# Inspection Report

Provided by: High Tide Inspections LLC

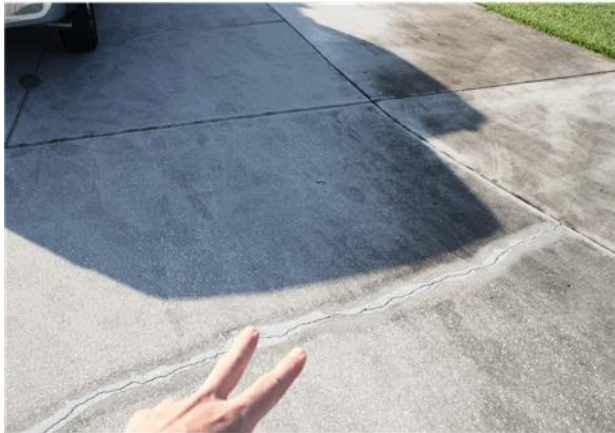
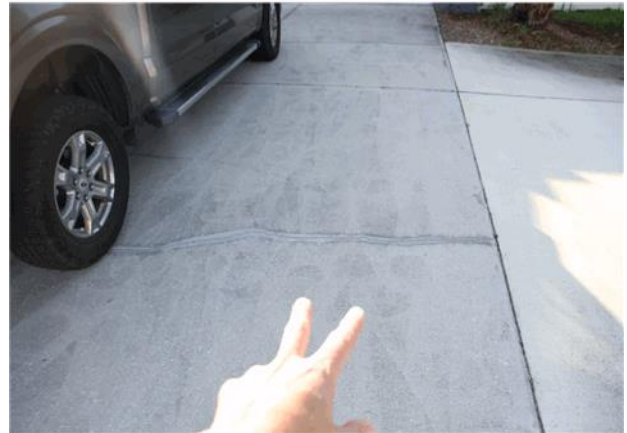
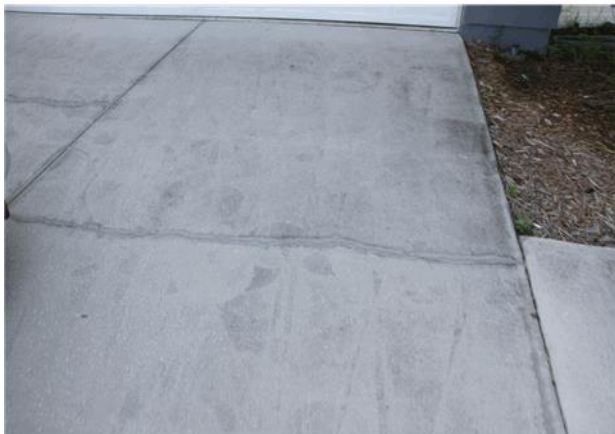
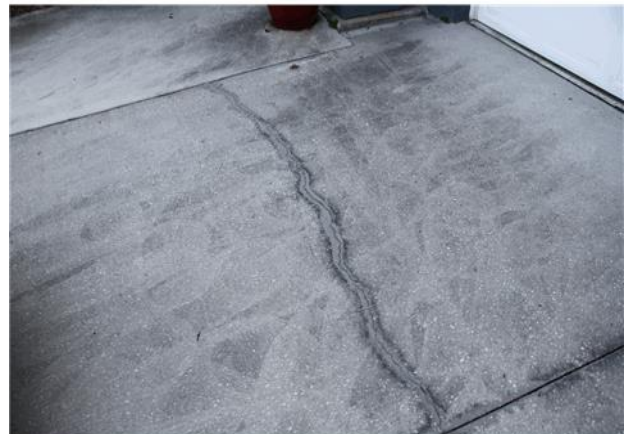
Common cracks were observed at driveway. Repair as needed.

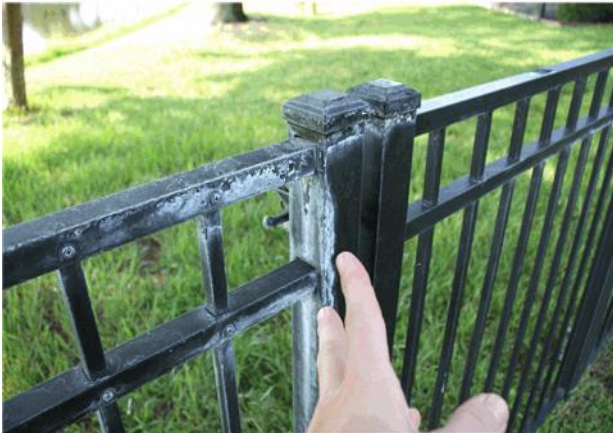
Damage and/or corrosion observed at one or more fences and/or gates. Recommend review/repair by a licensed professional as needed.

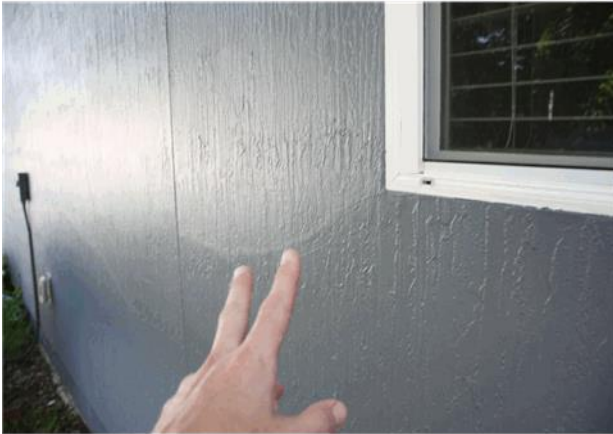
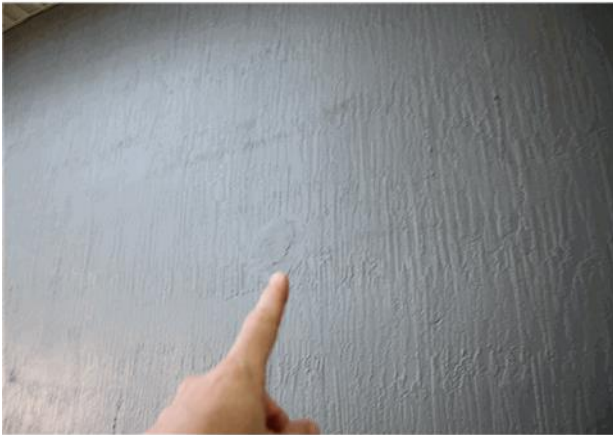
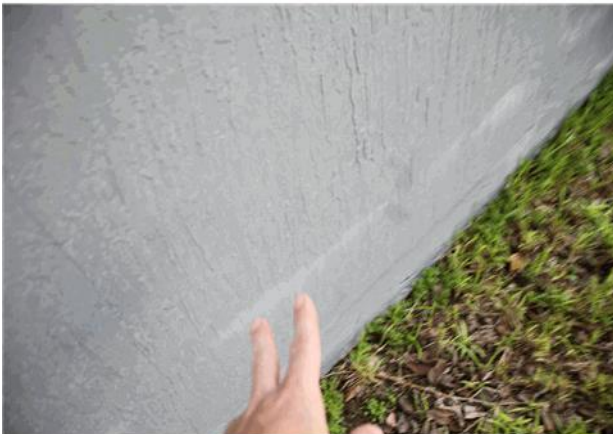
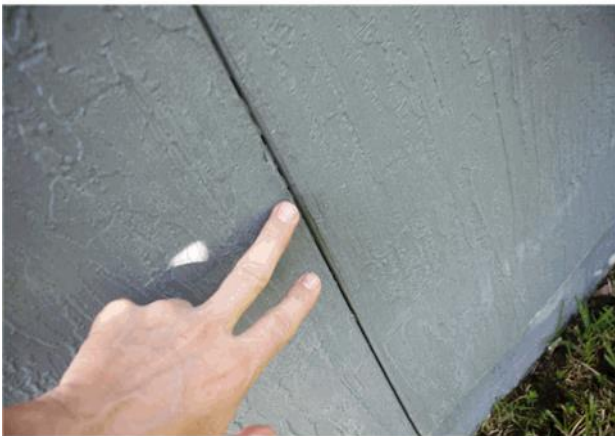
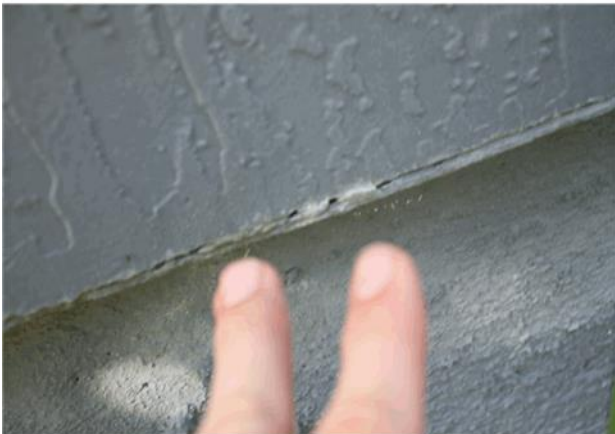
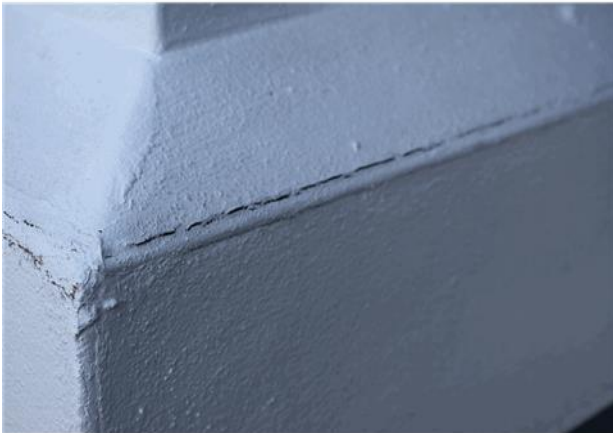
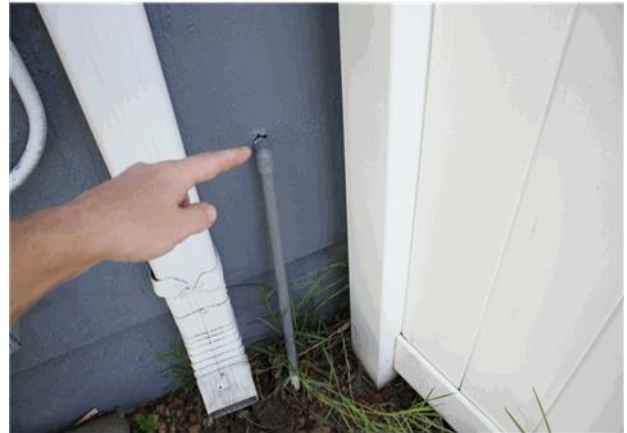
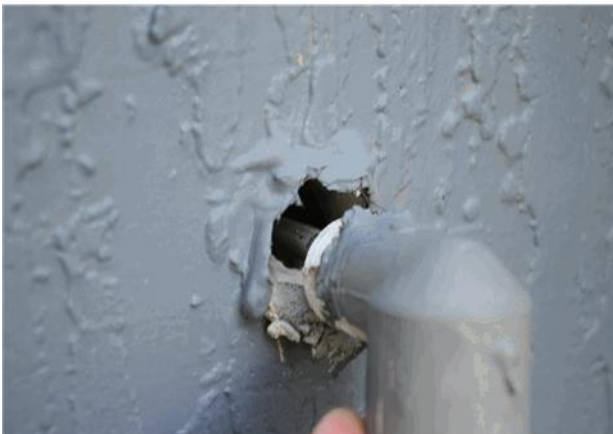
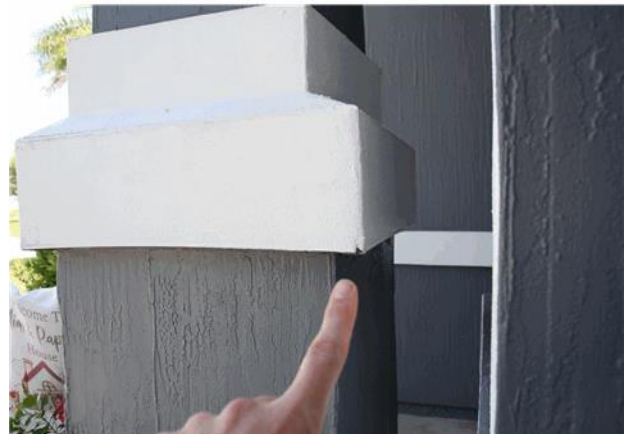
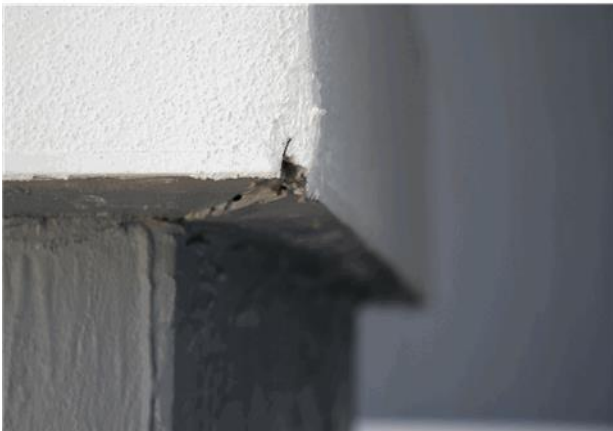
| Section | Condition# | Comment |
|---|---|---|
| Exterior | 5 | Repairs observed at one or more exterior walls. Damage observed at one or more exterior walls. Missing sealant and/or caulking observed at one or more exterior walls. Moisture stains and/or damage observed at one or more exterior walls and/or trim. Recommend review/repair by a licensed contractor. |

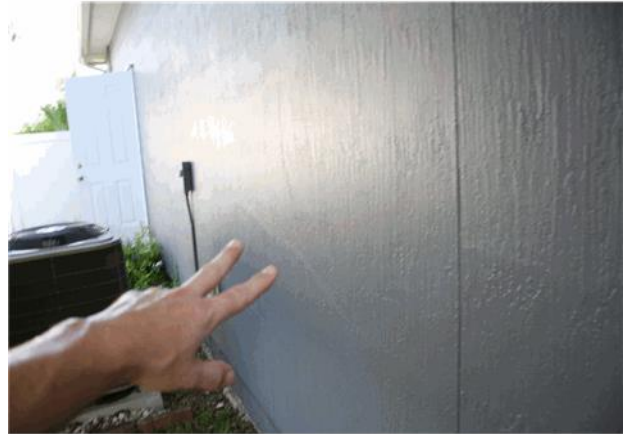
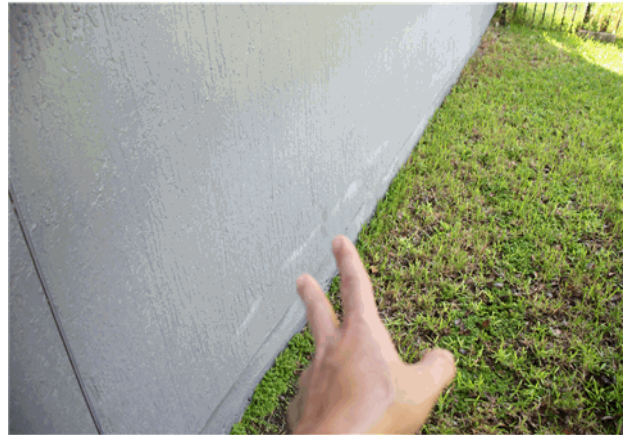
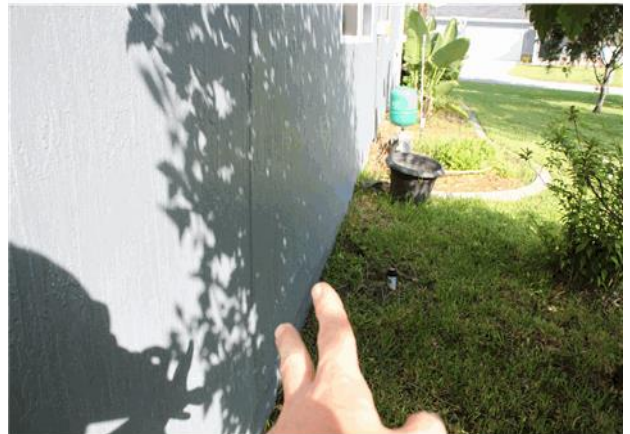
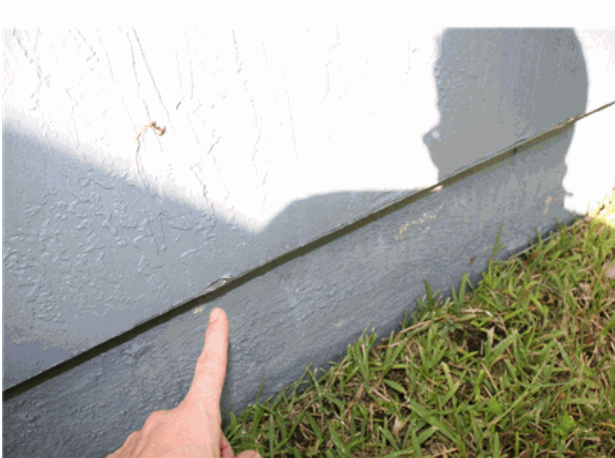
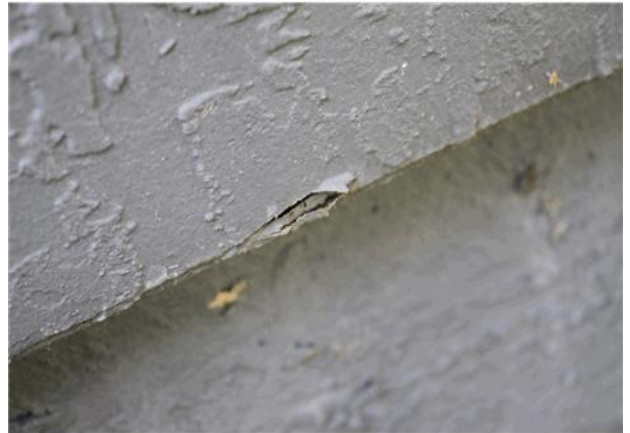
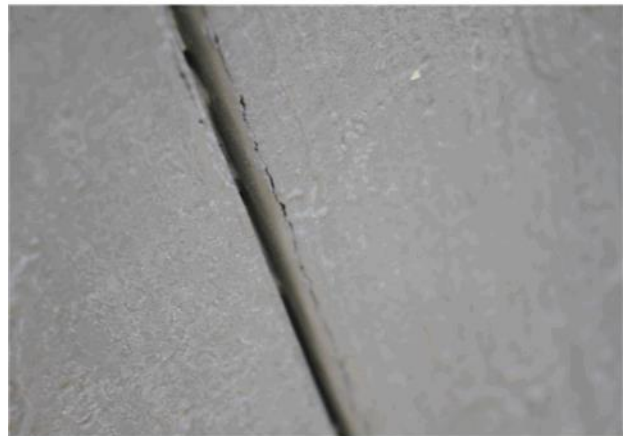
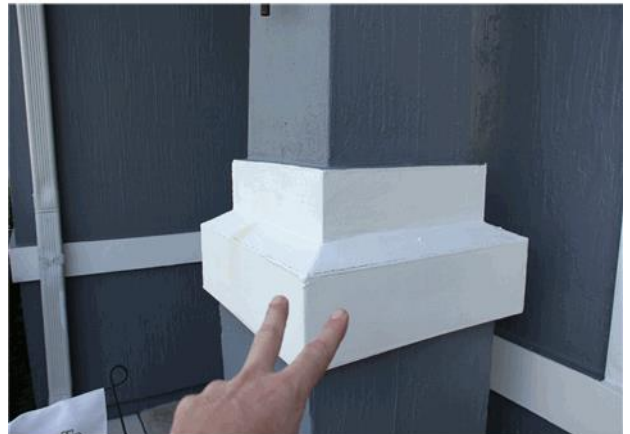
#### 5) Exterior Wall Conditions

Repairs observed at one or more exterior walls. Damage observed at one or more exterior walls. Missing sealant and/or caulking observed at one or more exterior walls. Moisture stains and/or damage observed at one or more exterior walls and/or trim. Recommend review/repair by a

licensed contractor.

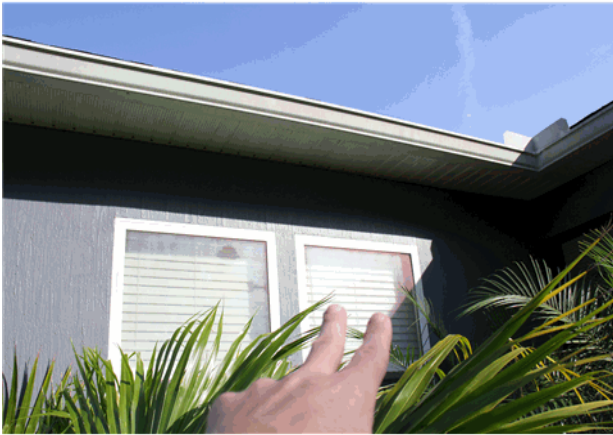
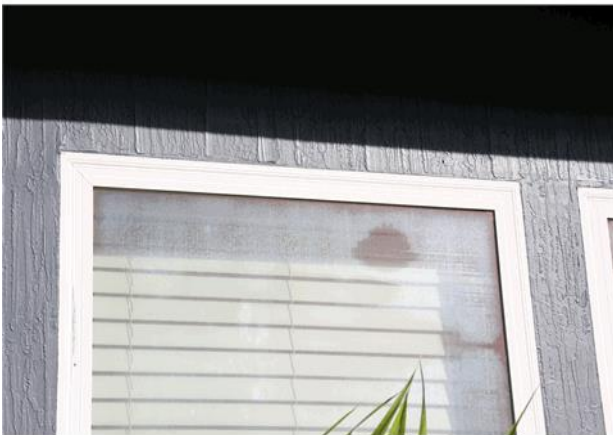
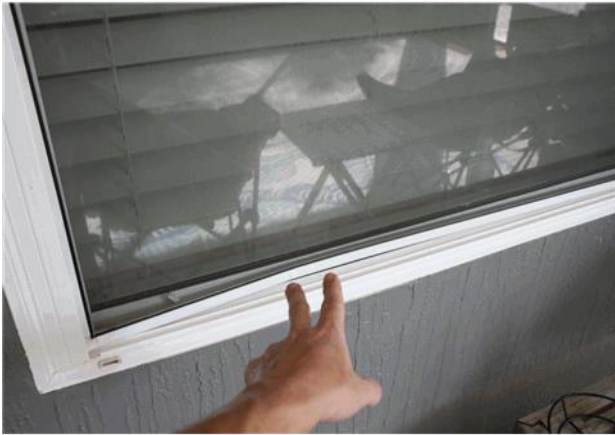
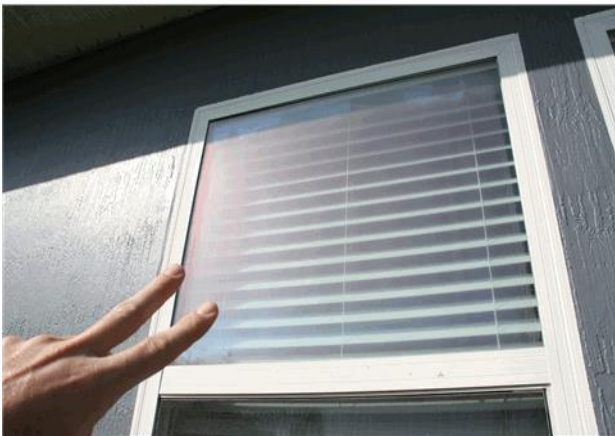
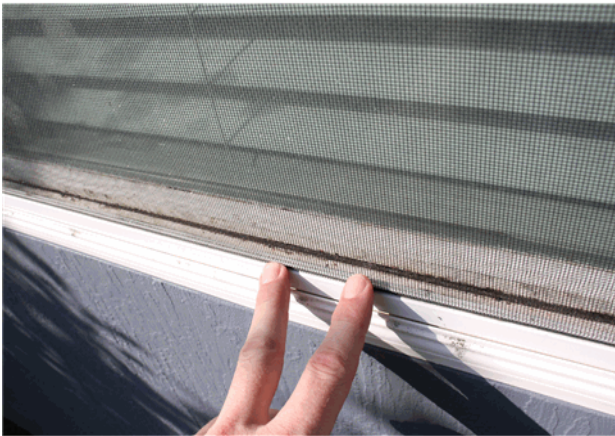
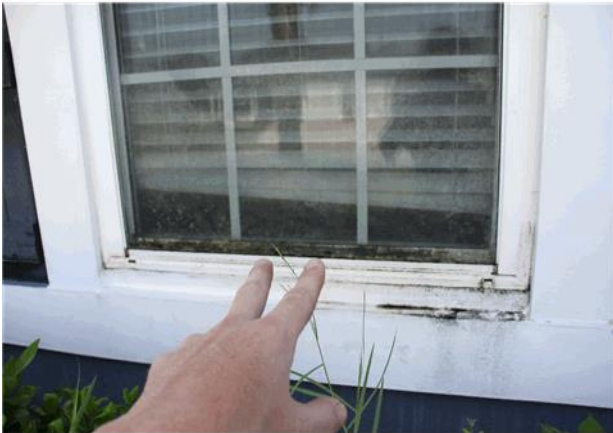
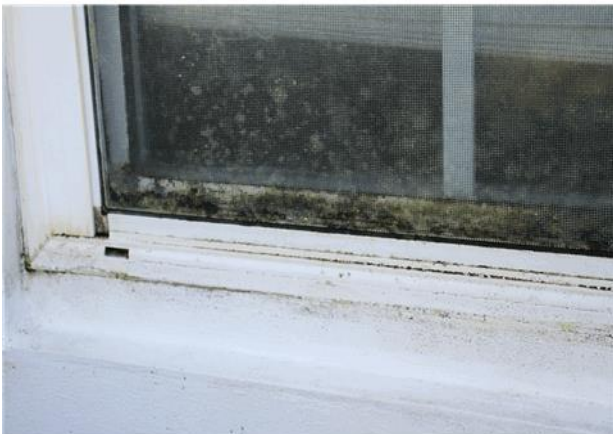
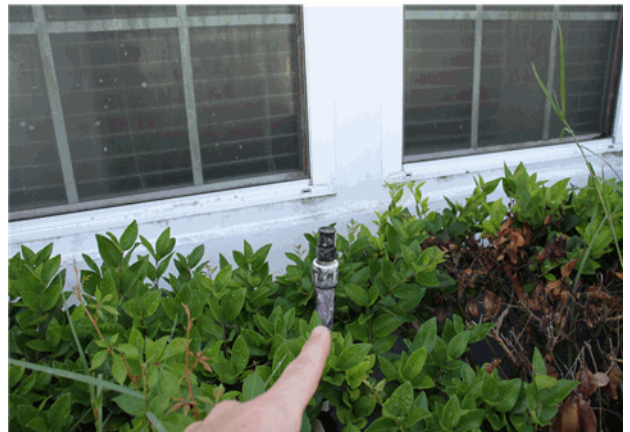
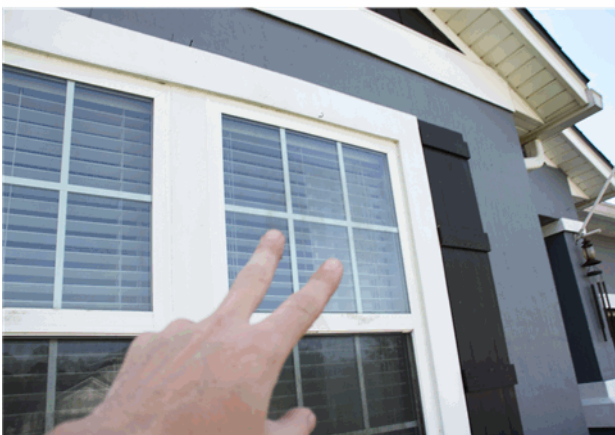
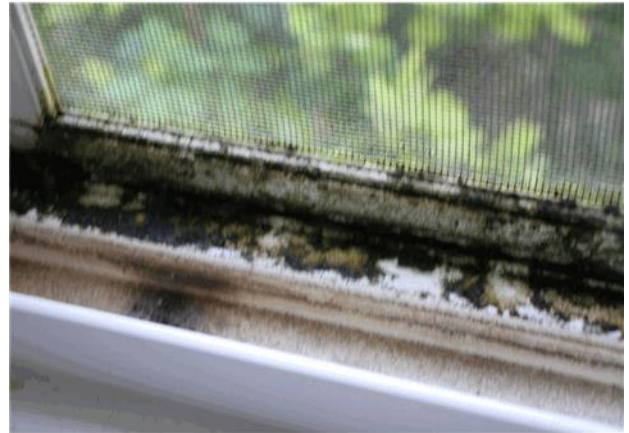
Fogging observed at one or more windows. One or more damaged and/or missing screens observed at exterior windows. Damage to one or more "thermal seals" observed at one or more exterior windows. "Algae" and/or "mildew" and/or moisture damage observed at one or more exterior windows and/or window frames. Recommend ensuring that sprinklers are turned away from the home's exterior. Recommend review/repair by a licensed contractor.

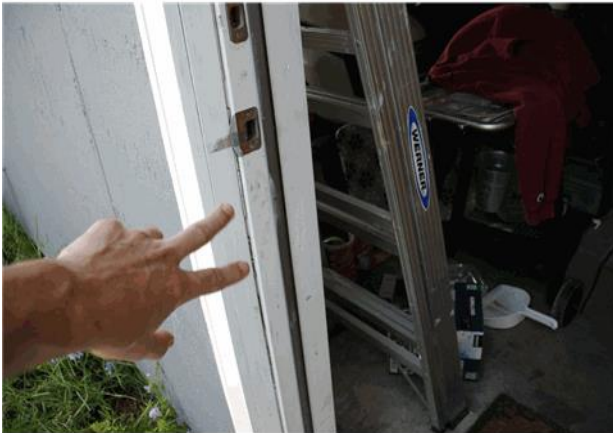
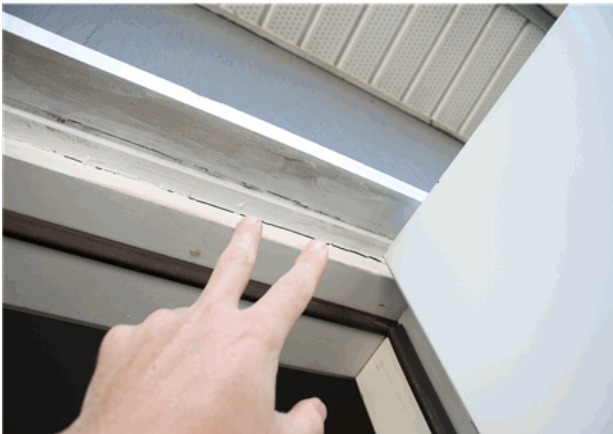
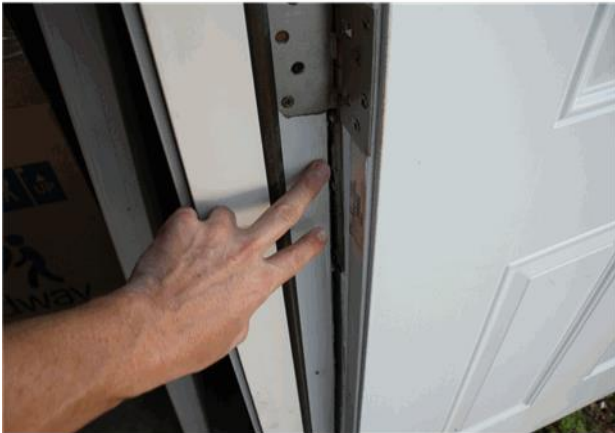
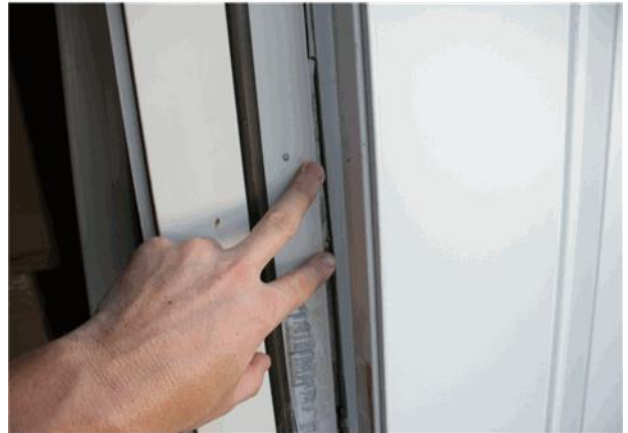
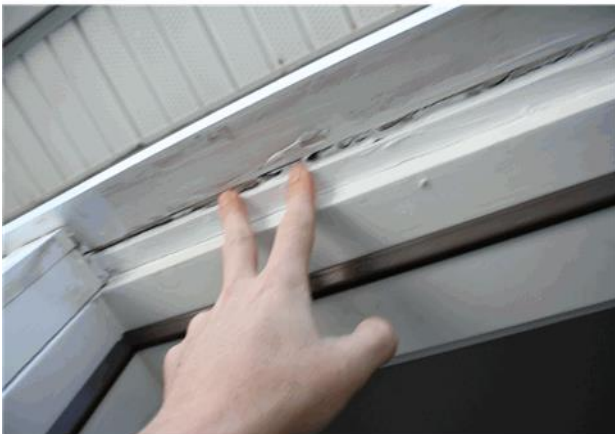
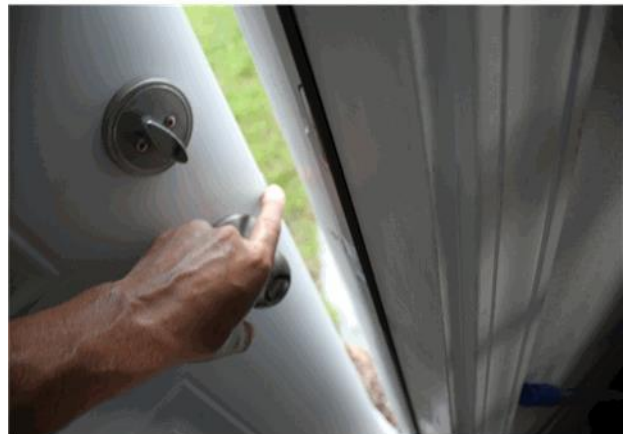
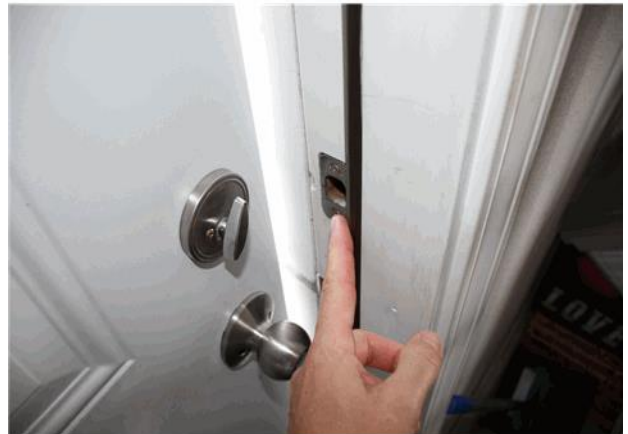
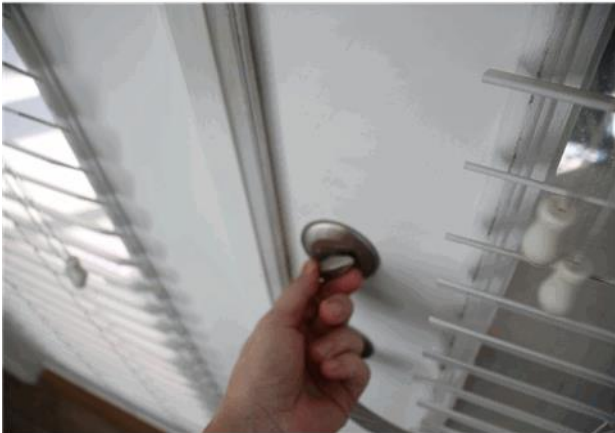
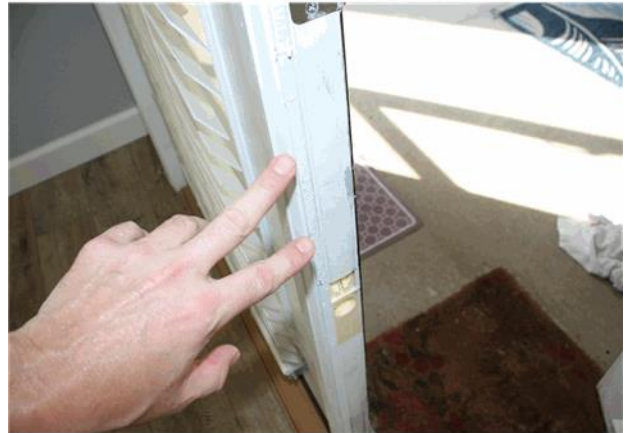
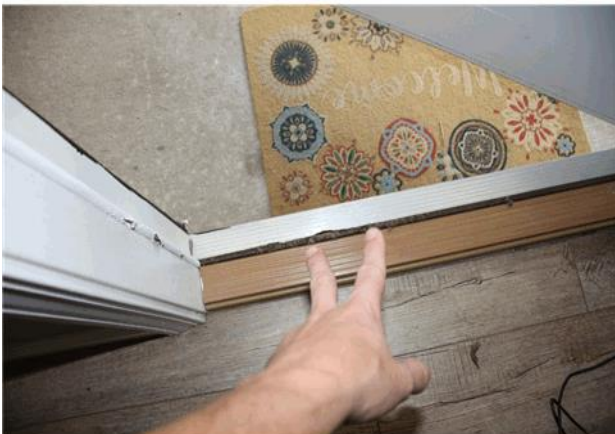
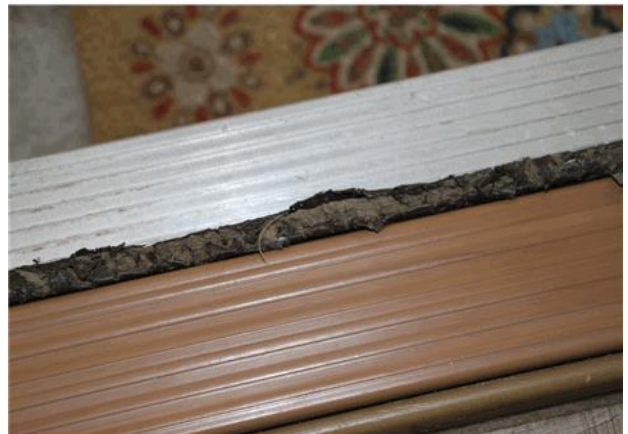
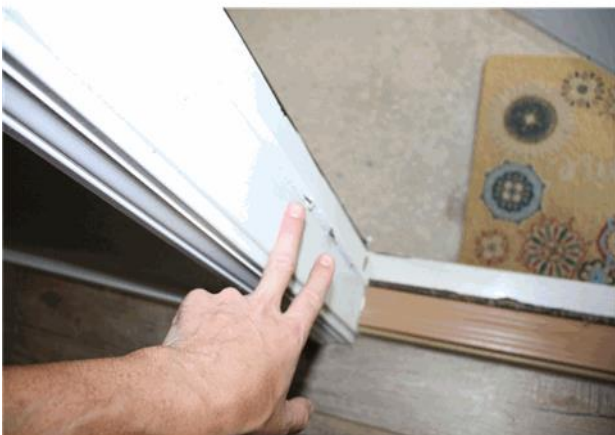
## 7) Exterior Door Conditions

Missing sealant and/or caulking observed at one or more exterior doors and/or door frames. Moisture stains and/or damage observed at one or more exterior doors and/or door frames. One or more exterior doors and/or door hardware did not function properly at the time of inspection. The weather seal was missing and/or damaged at one or more exterior doors. Recommend review/repair by a licensed handyman.

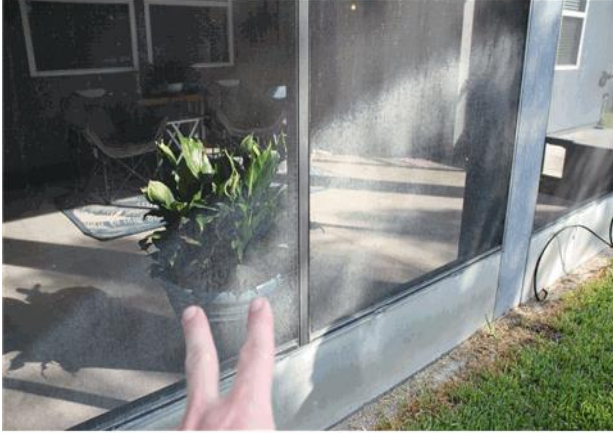
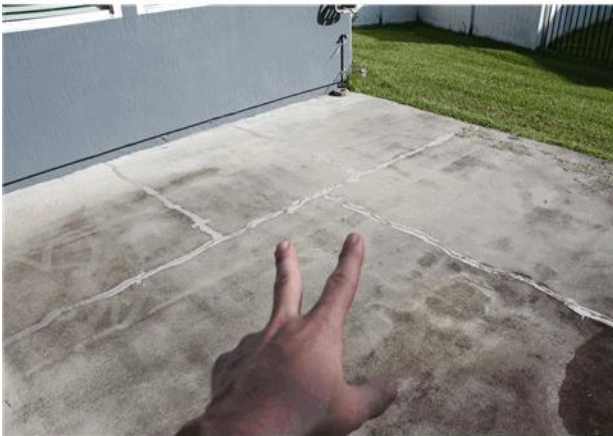
### 8) Wood and Masonry Deck Conditions

Minor damage and/or corrosion observed at one or more porches. Recommend review/repair by a licensed contractor.

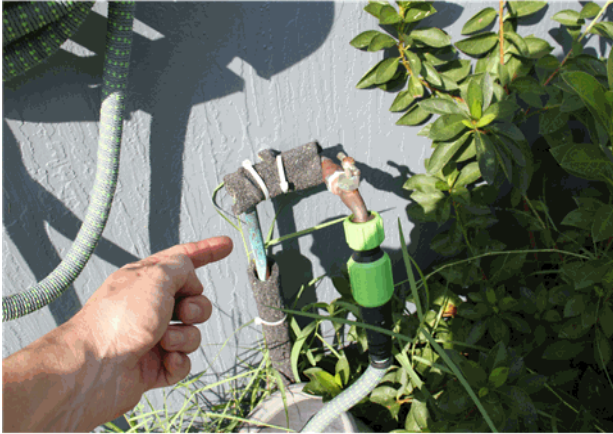
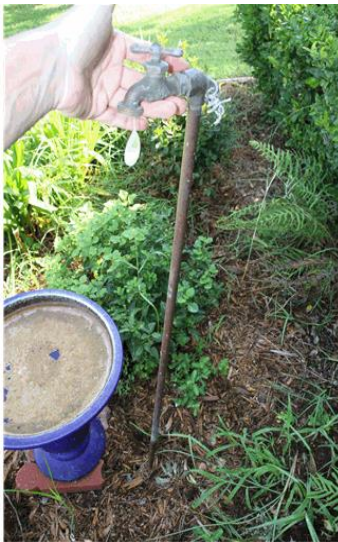
### 11) Faucet Conditions

One or more exterior faucets were missing insulation. One or more exterior faucets were not functional. Recommend review/repair by licensed plumber.

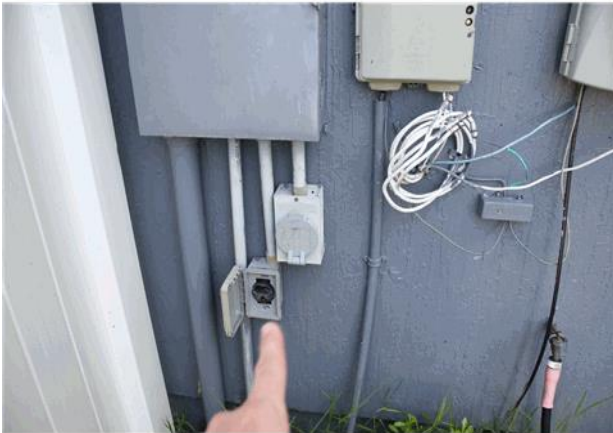
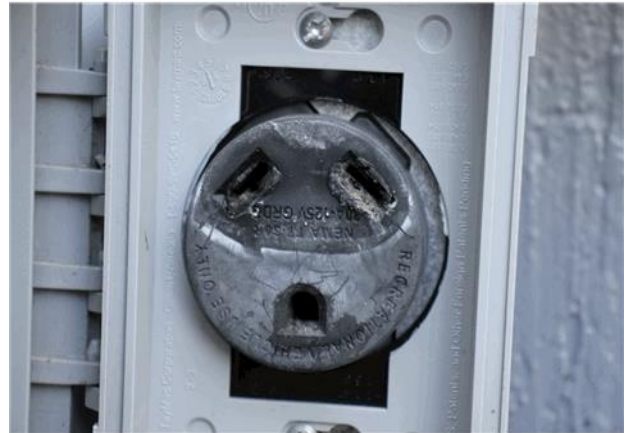
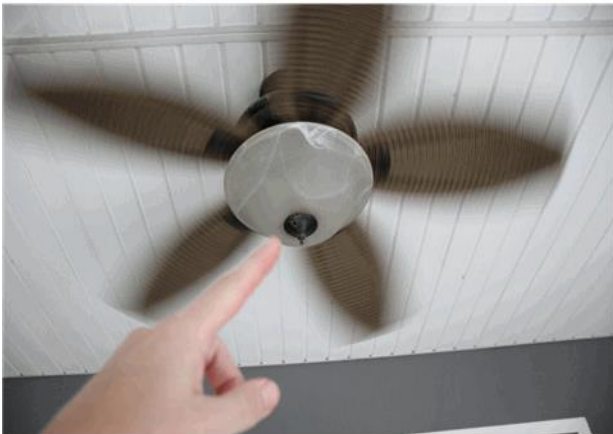
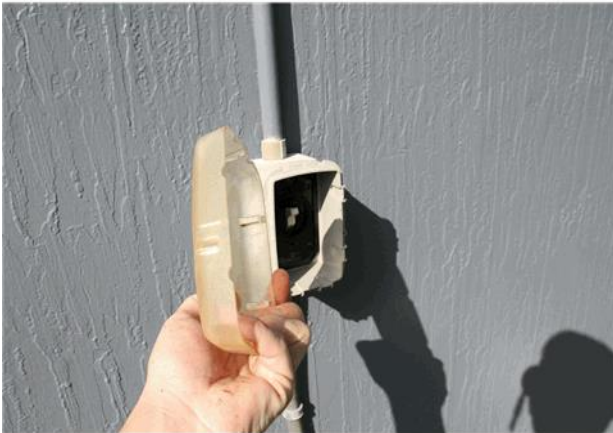
### 12) Exterior Electric Conditions

Damage observed at one or more exterior outlets. Exposed wiring observed at one or more exterior lights. One or more exterior lights did not function at the time of inspection. Missing pull cord/s observed at ceiling fan. Recommend review/repair by a licensed electrician.

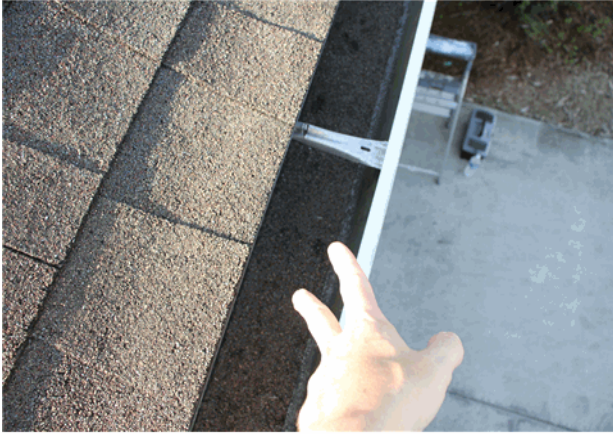
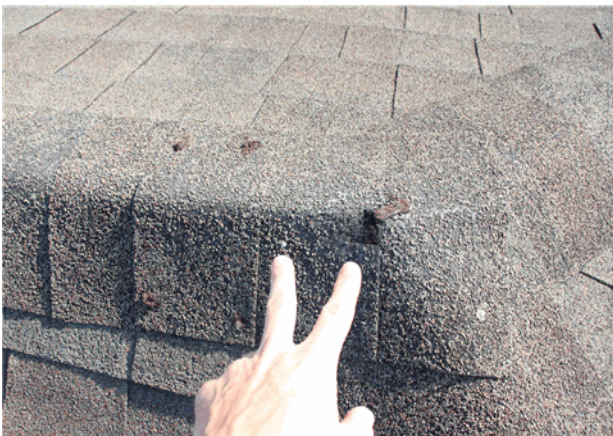
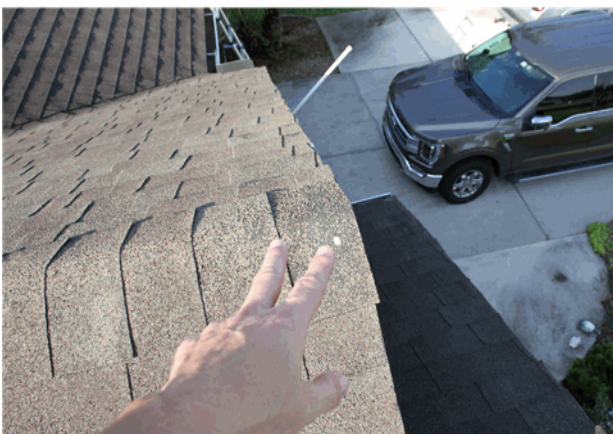
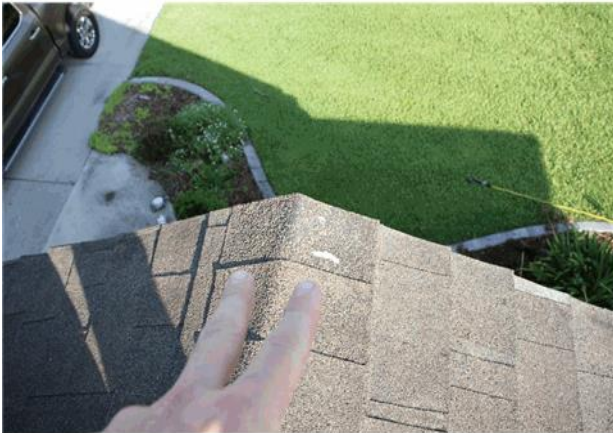
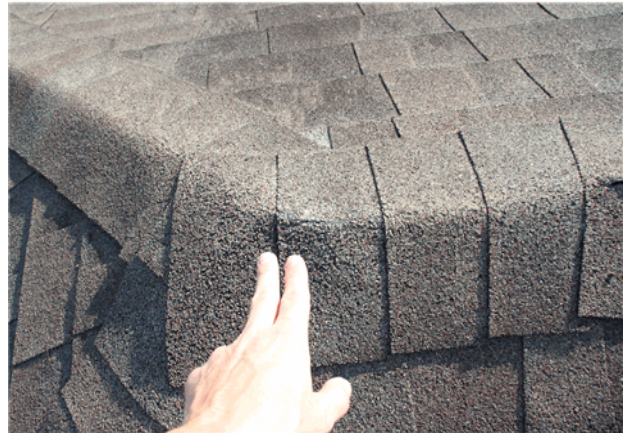
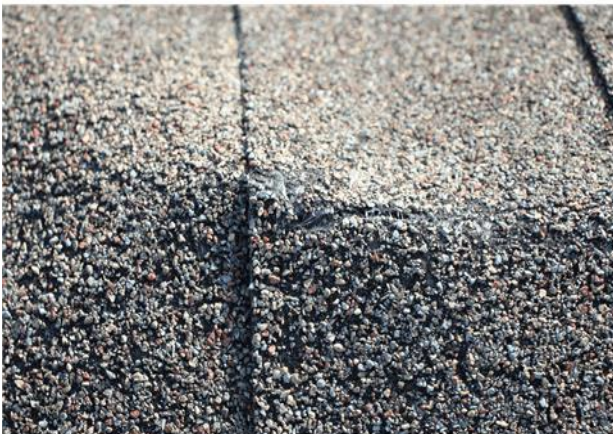
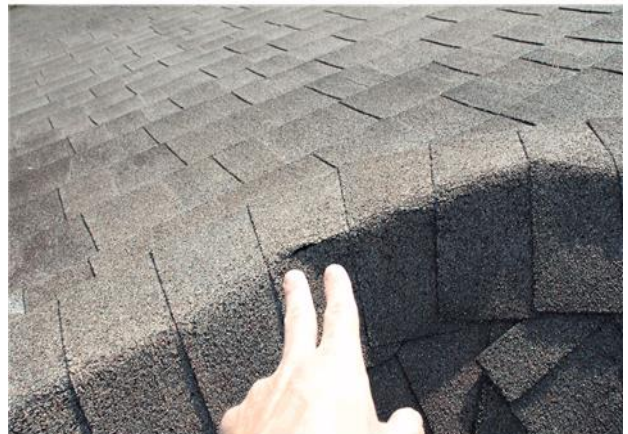
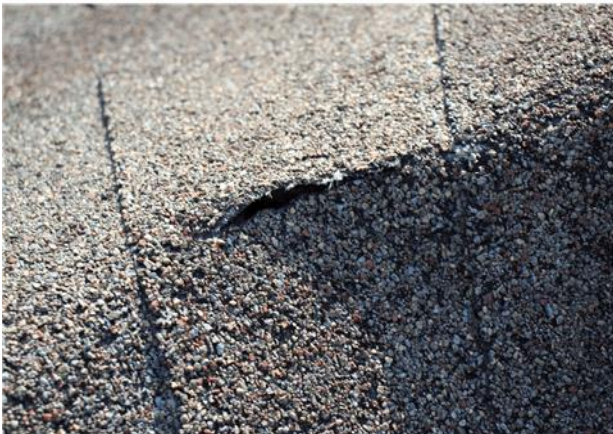
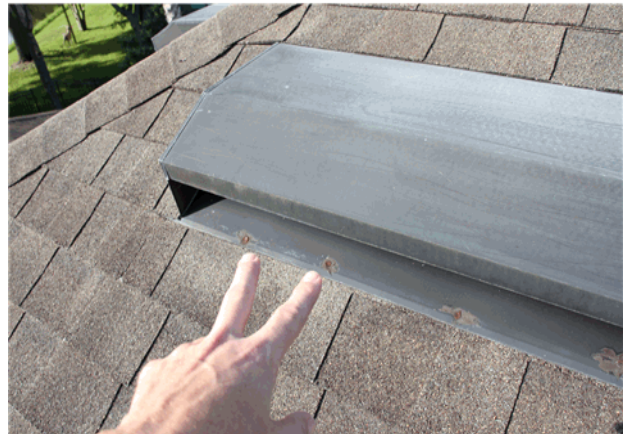
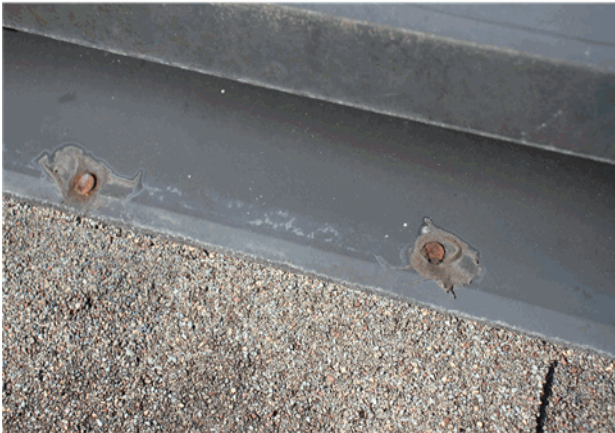
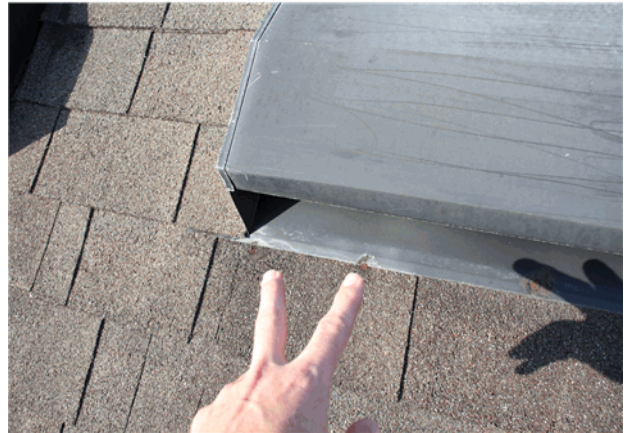
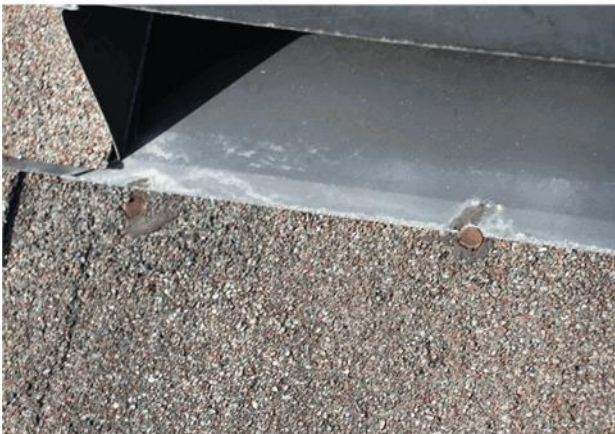
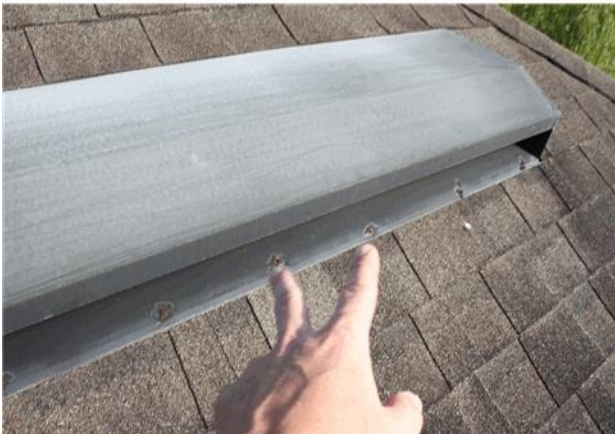
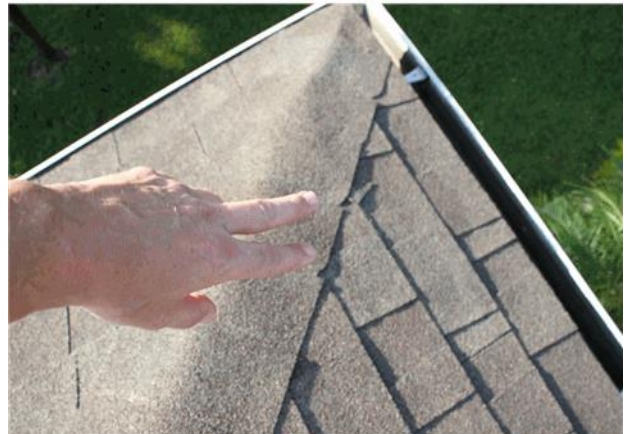
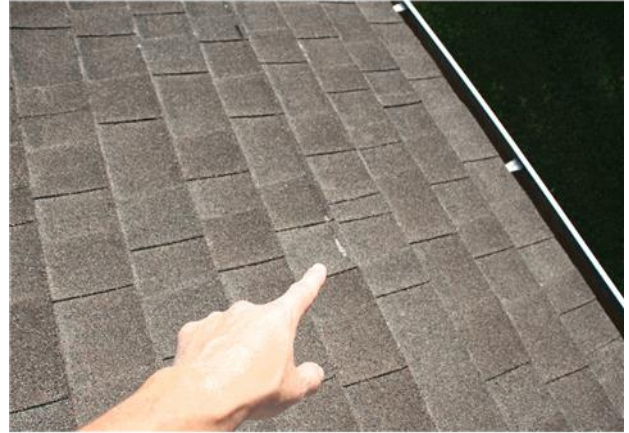
### 13) Roof Covering Condition

One or more damaged shingles observed. Excessive granule loss observed. One or more exposed nails observed. The roof is nearing the end of its useful life. Recommend review/repair by a licensed roofing contractor.

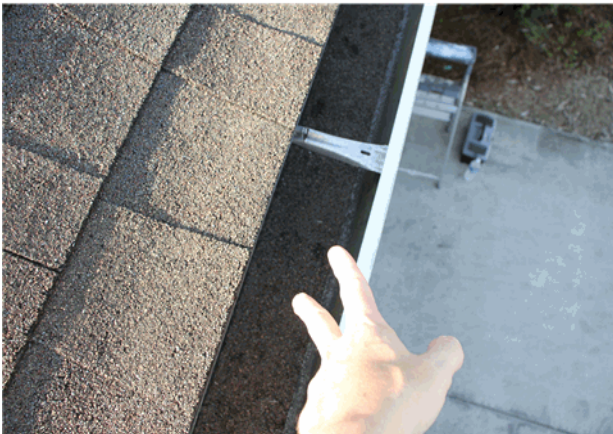
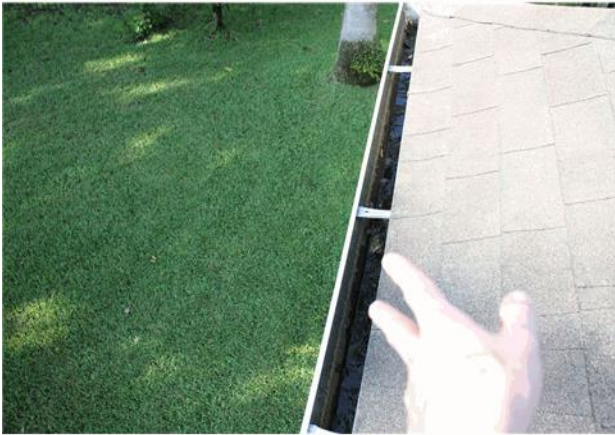
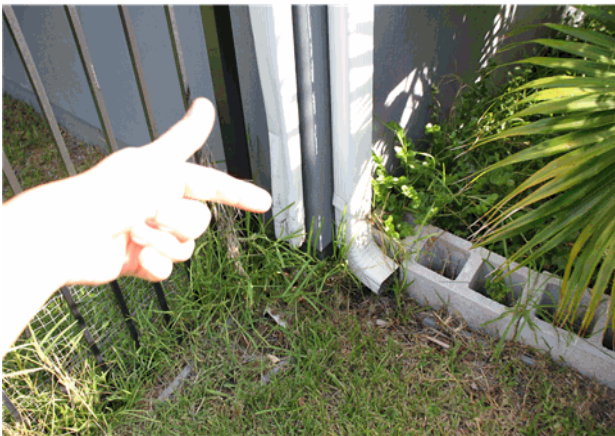
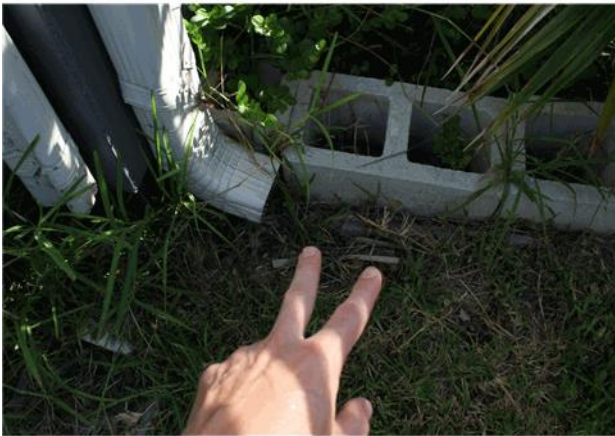
#### 15) Gutter & Downspout Conditions

Debris observed in one or more gutters. Suggest cleaning and removal of debris on a regular basis. Ponding observed at one or more gutters. Damage observed. One or more downspouts were missing a "splash plate." Recommend installing "splash plates" to reduce soil erosion.

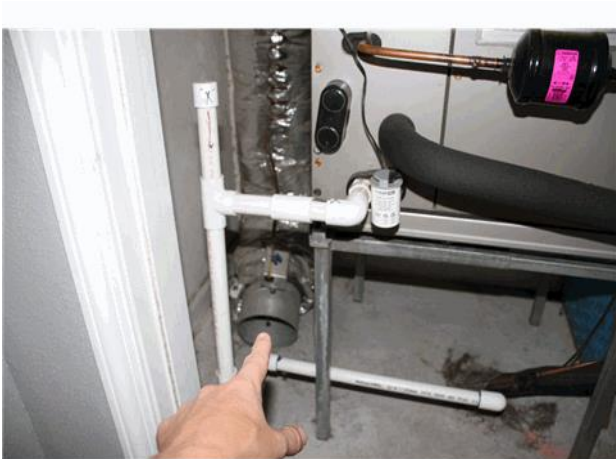
**21) Distribution Conditions** RR "Disconnected" ductwork observed. Minor damage to ductwork observed. Recommend review and/or repair by a licensed HVAC company.

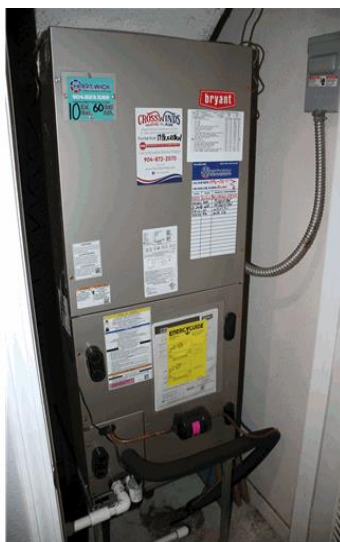
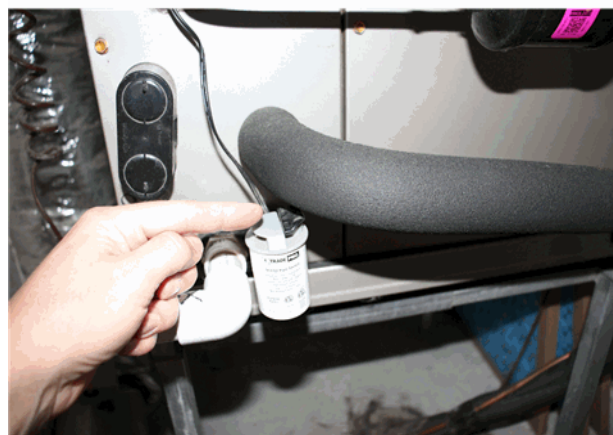
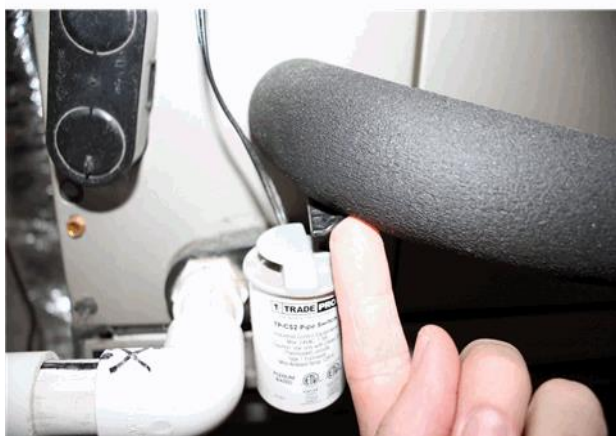
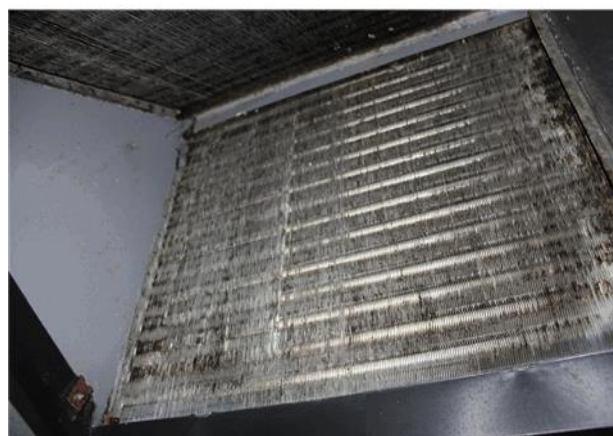
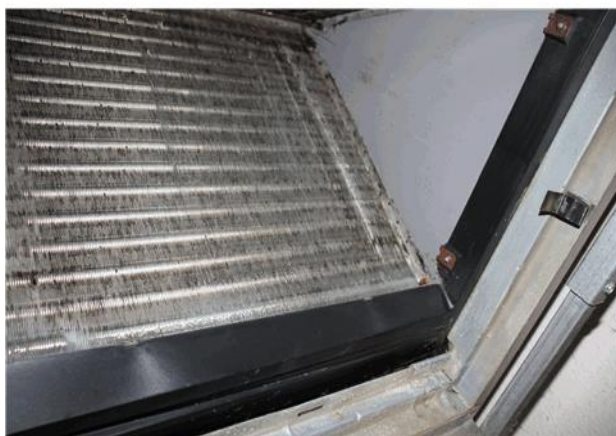
**24) Air Handler  
Conditions**

The "float switch" did not appear to function at the time of inspection. "Dirt" and/or "mildew" observed inside of air handler. Recommend review and/or repair by a licensed HVAC company.

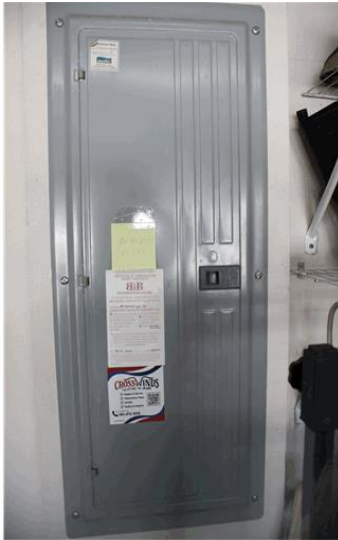
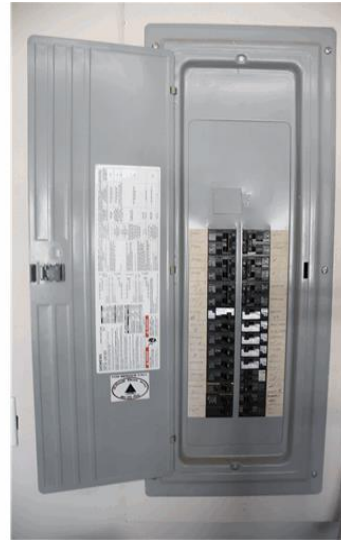
**28) Subpanel Conditions**

**Subpanel Location** A sub panel is located at the garage.

AS
