# Inspection Report

Provided by: High Tide Inspections LLC

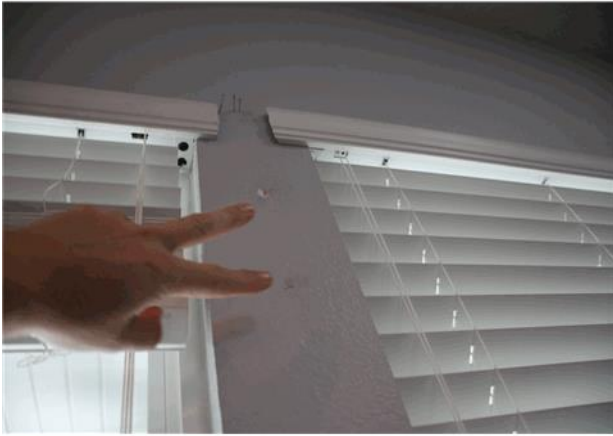
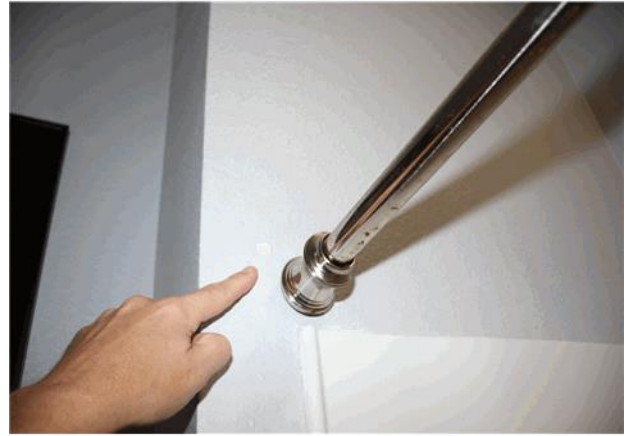
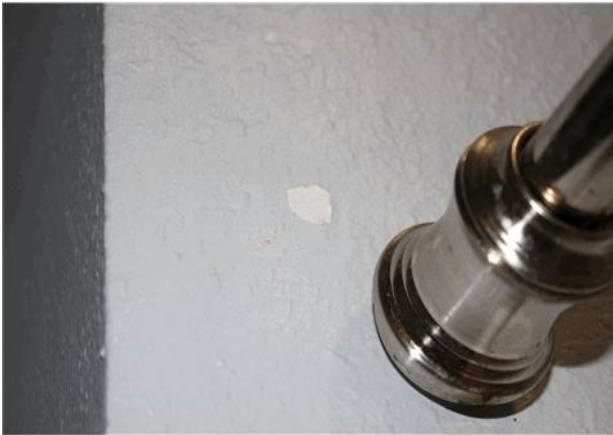
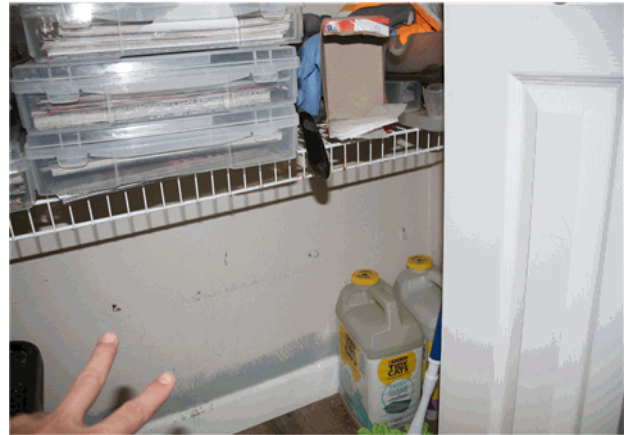
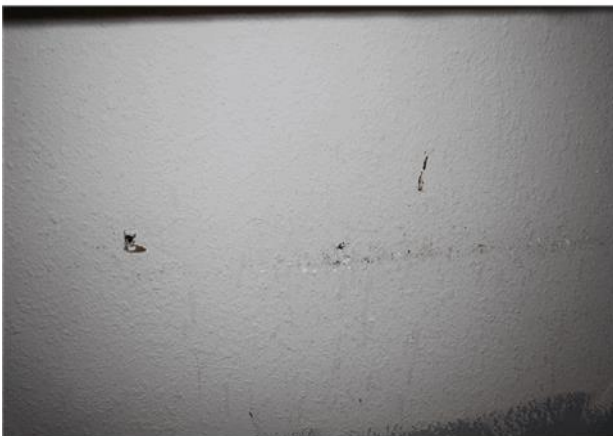
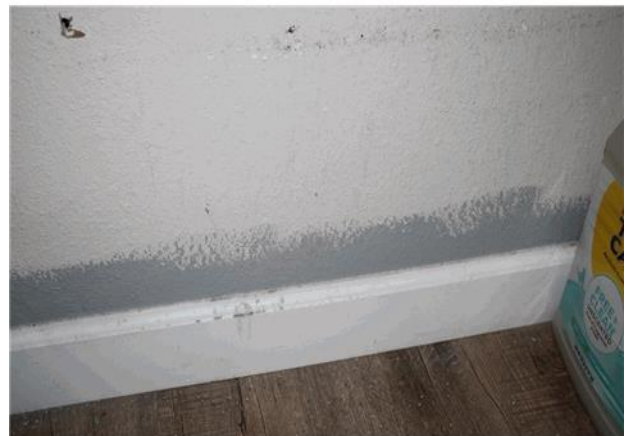
#### 33) Wall Conditions

Normal "wear and tear" observed at interior walls. Damage and/or cracks observed at one or more interior walls. Missing sealant and/or caulking and/or paint observed at one or more interior walls and/or trim. Repairs observed at one or more interior walls. Recommend

review/repair by a licensed handyman.

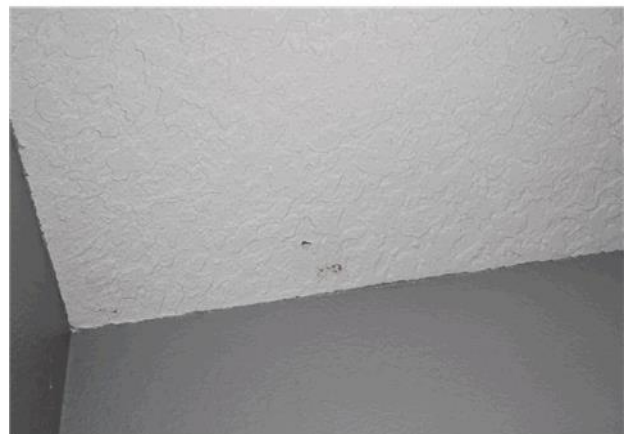
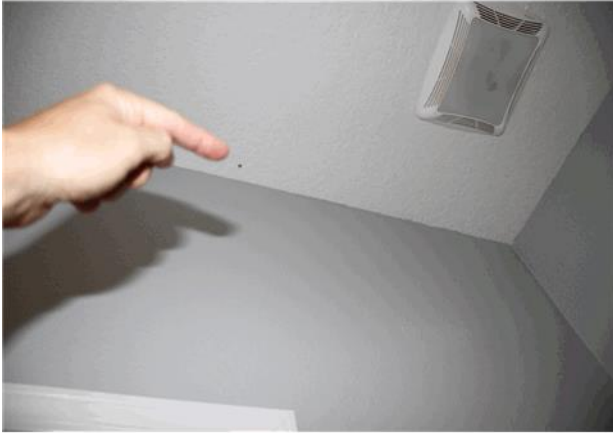
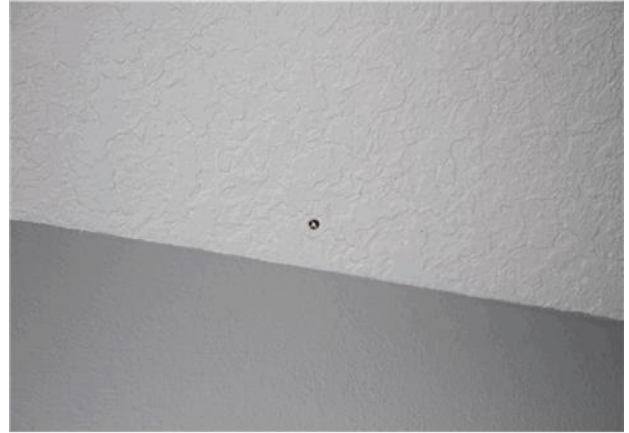
### 34) Ceiling Conditions

Minor damage observed at one or more interior ceilings. One or more "nail pops" observed at interior ceiling. Recommend review/repair by a licensed handyman.

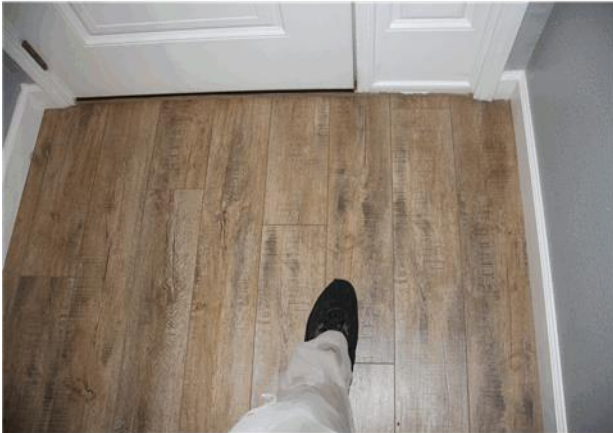
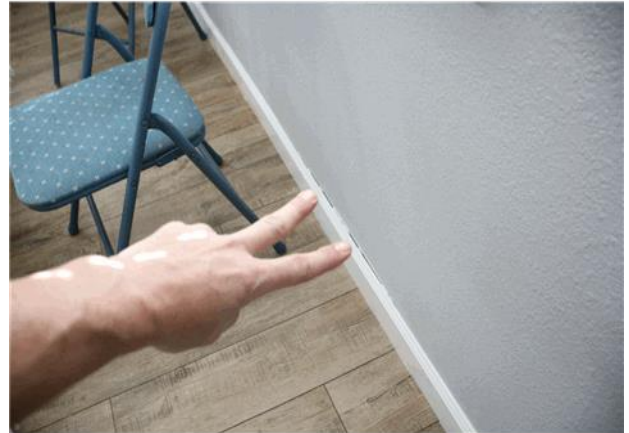
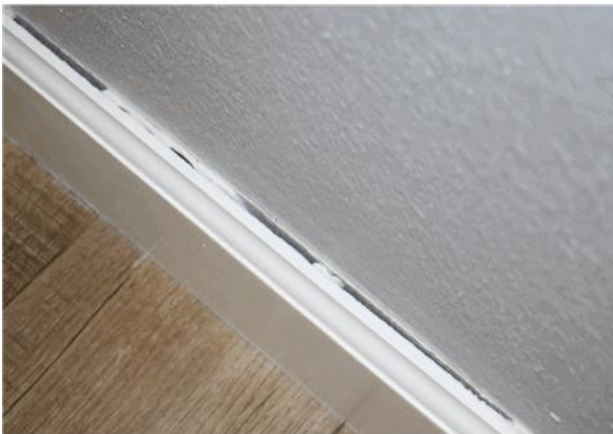
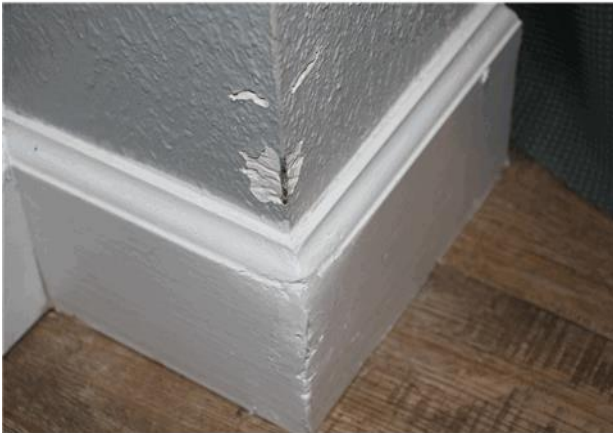
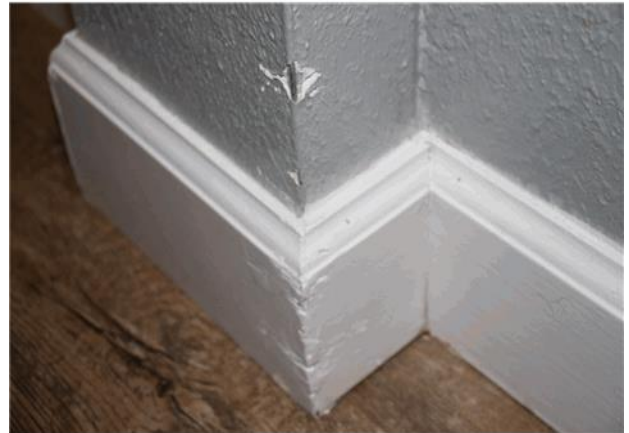
### 35) Floor Conditions

"Loose" flooring observed. Repair as needed. Missing sealant observed at one or more baseboards. Minor damage observed at one or more baseboards. Repair as needed.

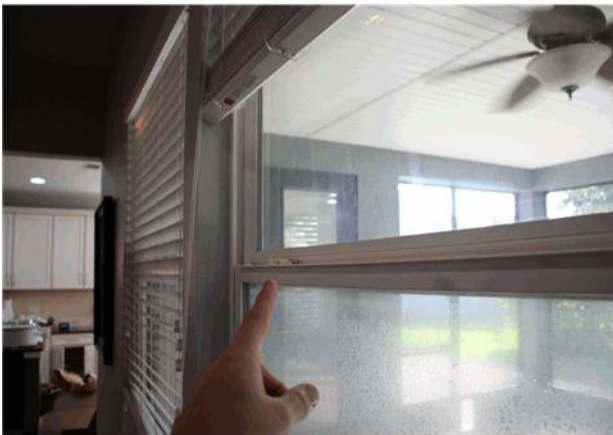
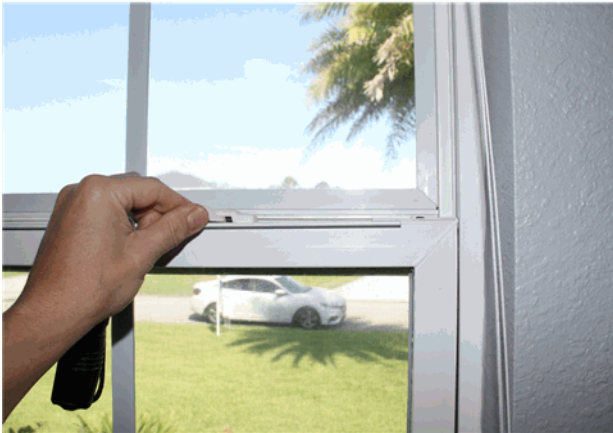
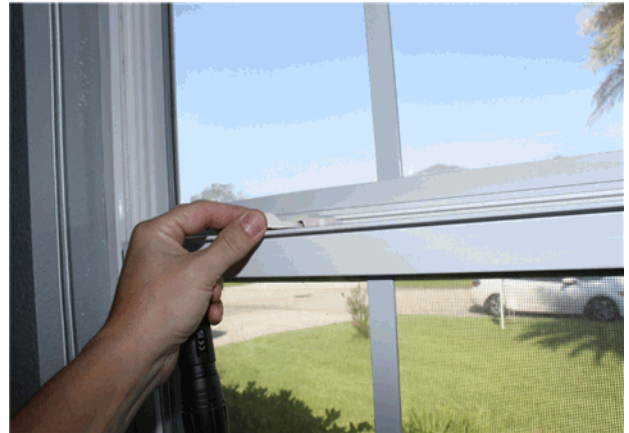
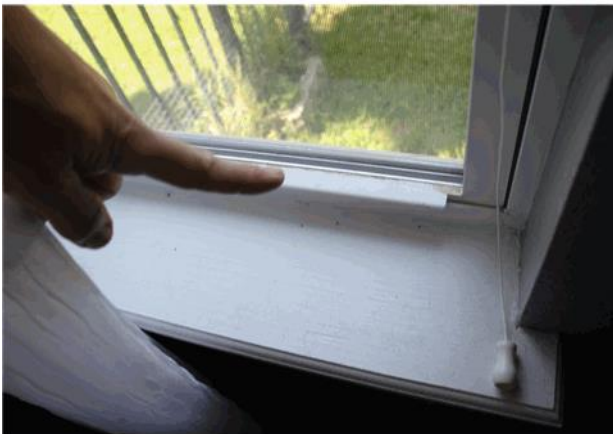
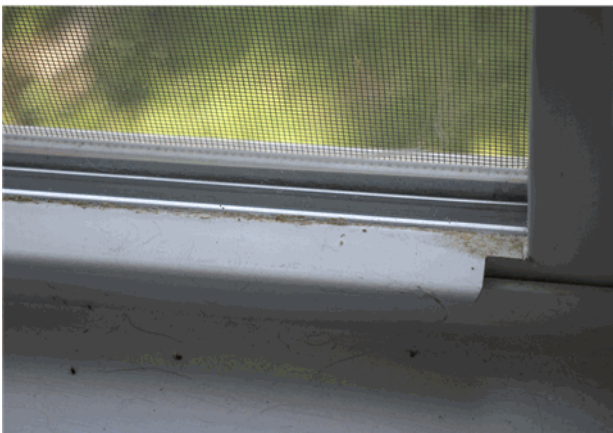
**37) Interior Window  
Conditions**

Damage observed at one or more interior windows and/or window frames and/or hardware. Minor corrosion observed. Recommend review/repair by a licensed professional.

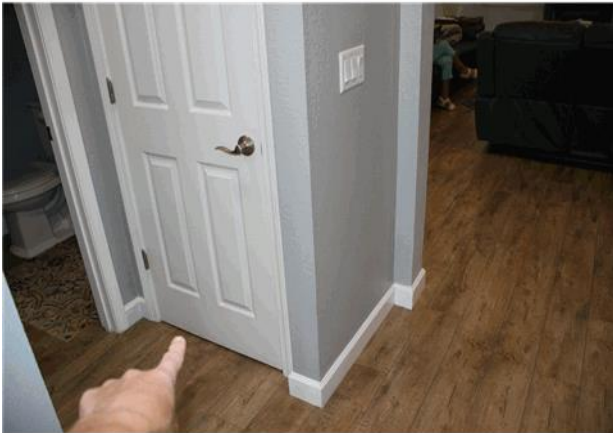
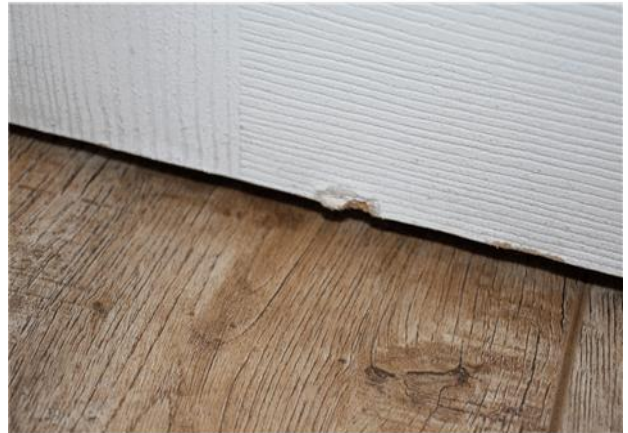
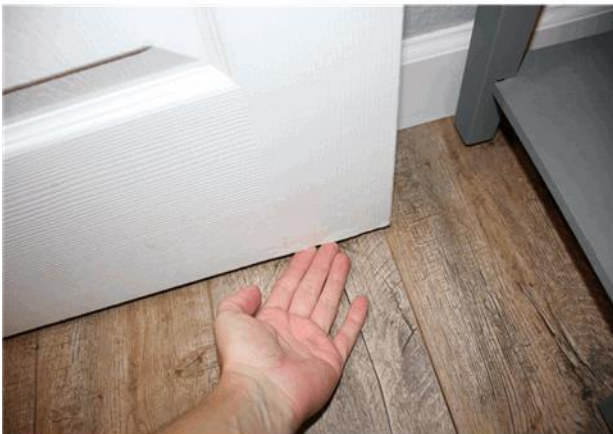
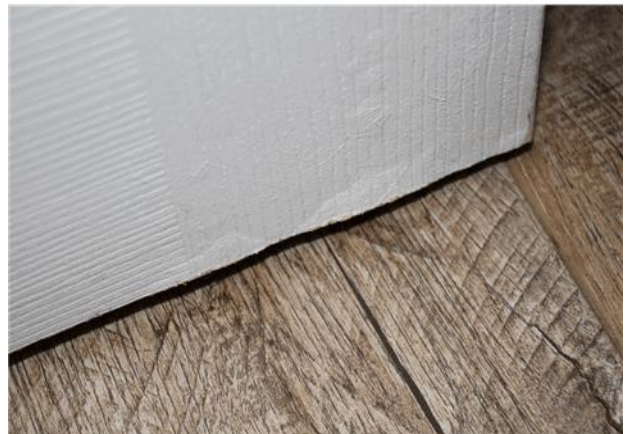
### 38) Interior Door Conditions

Minor damage observed at one or more interior doors. Repair as needed.

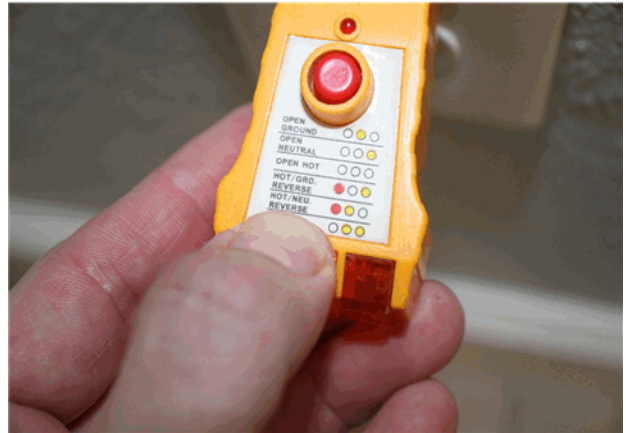
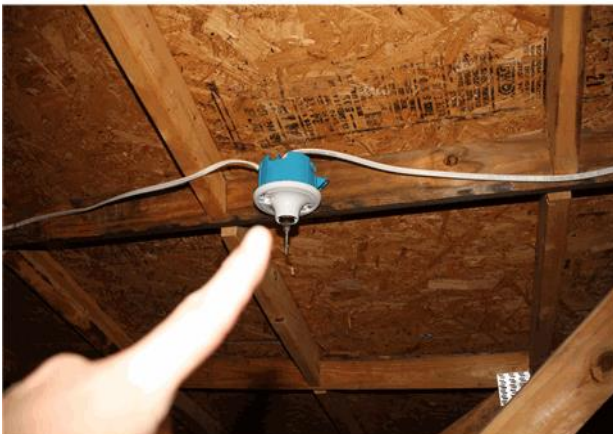
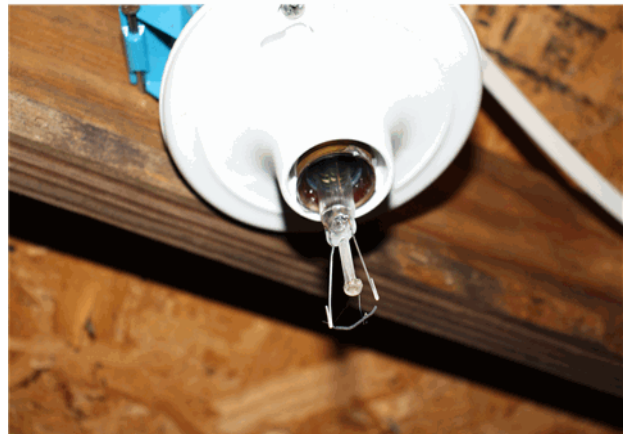
### 39) Electrical Conditions

One or more interior outlets tested for "hot / neutral reverse." One or more lights and/or bulbs were damaged in attic. Recommend review/repair by a licensed electrician.

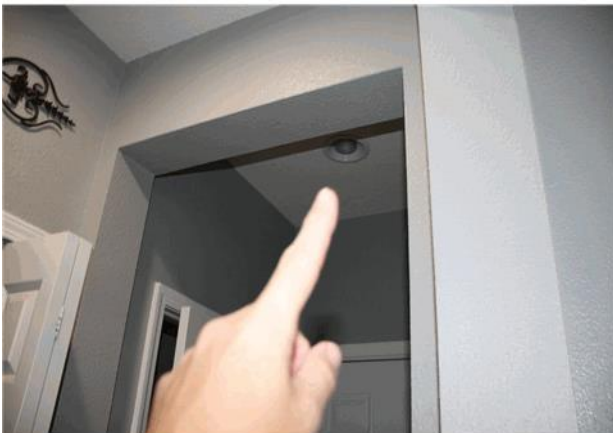
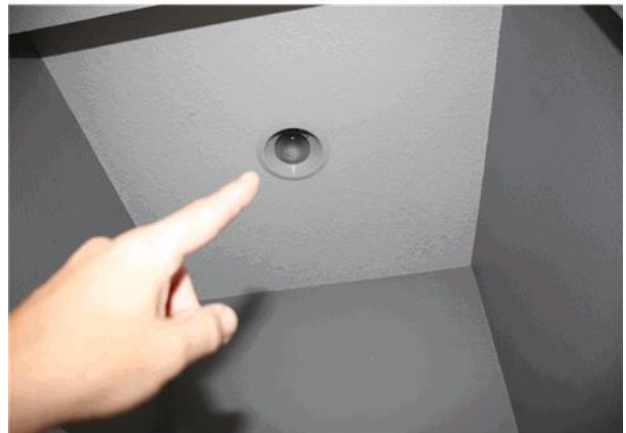
#### 40) Lighting Conditions

One or more interior lights did not function at the time of inspection. Recommend replacing bulb/s or review/repair by a licensed electrician.

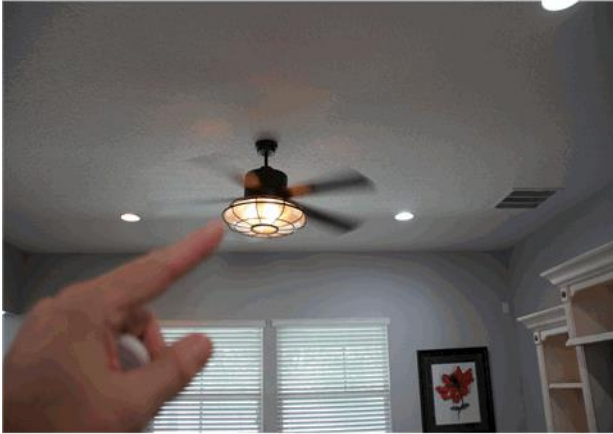
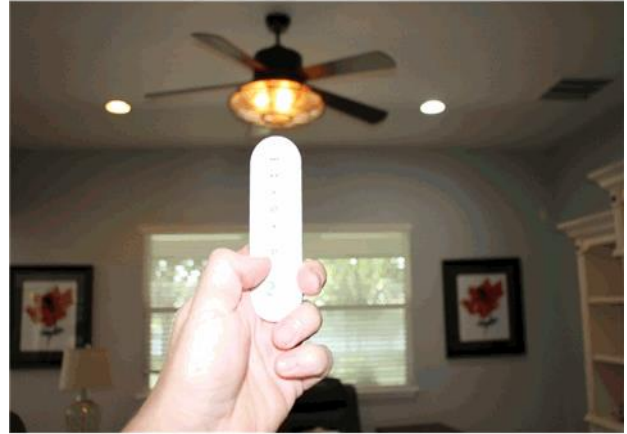
#### 41) Ceiling Fan Conditions

One or more ceiling fans wobbled when operated. The "remote" did not turn the light on and off. Repair as needed.

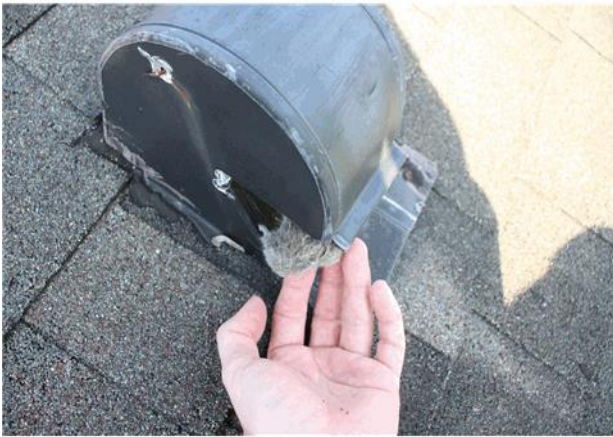
#### 43) Laundry Room Conditions

"Lint" observed in dryer vent. Recommend cleaning by a licensed professional. One or more cabinets and/or drawers did not function properly in laundry. Recommend review/repair by a licensed handyman. Damage observed at dryer. Repair / replace as needed.

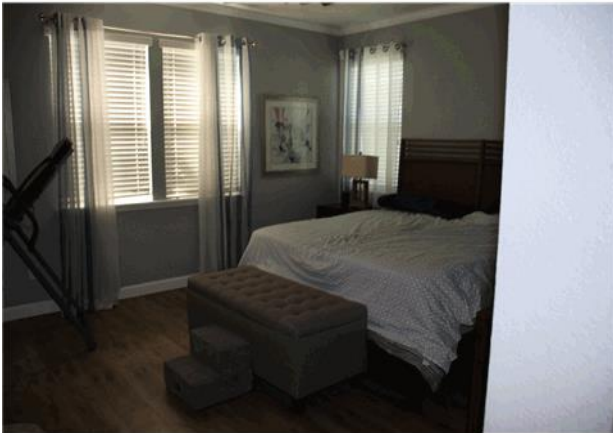
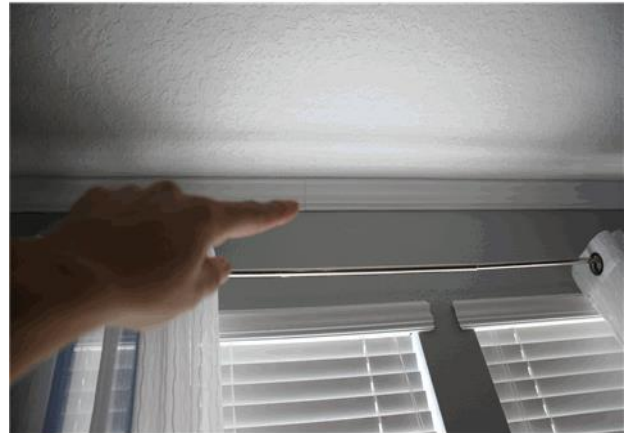
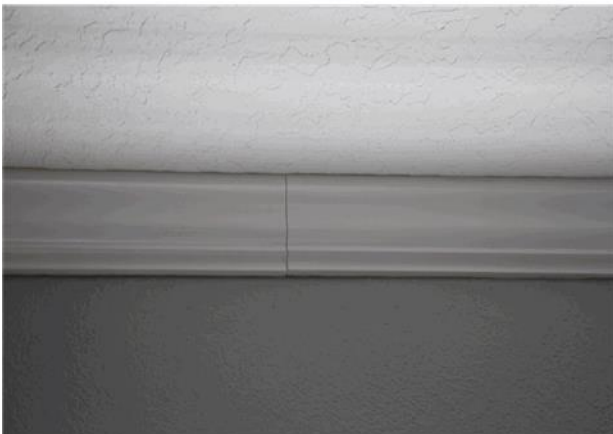
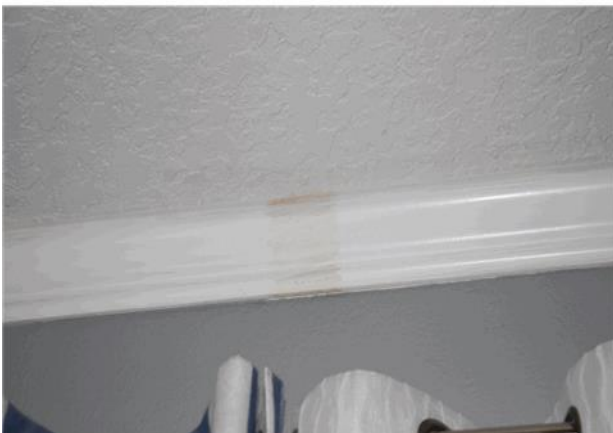
#### 45) Ceiling Conditions

Missing sealant and/or caulking observed at ceiling trim in master bedroom. One or more "stains" observed at trim in master bedroom. No active moisture detected. Recommend review/repair by a licensed handyman.

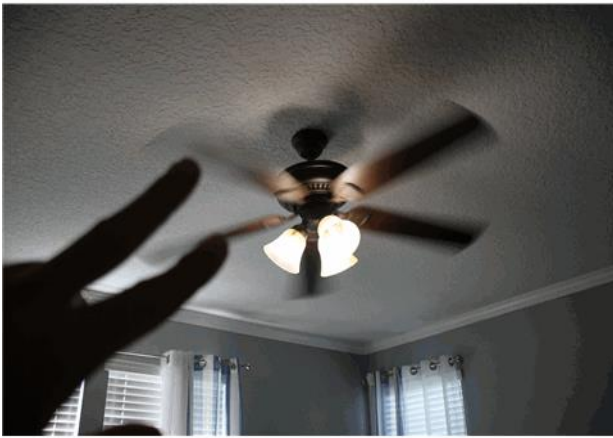
52) Ceiling Fan  
Conditions

The ceiling fan made an unusual noise in master bedroom. The inspector was unable to locate ceiling fan "remote." Repair as needed.

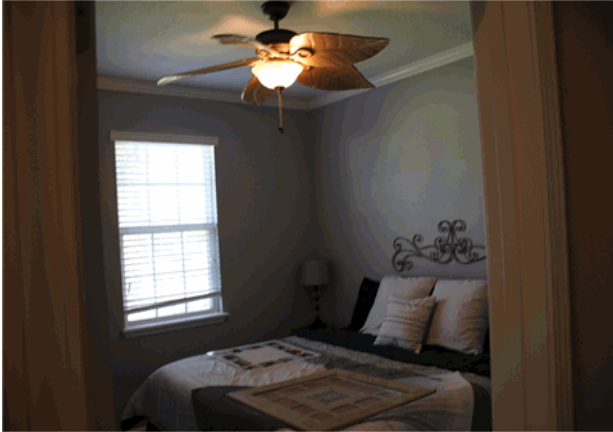
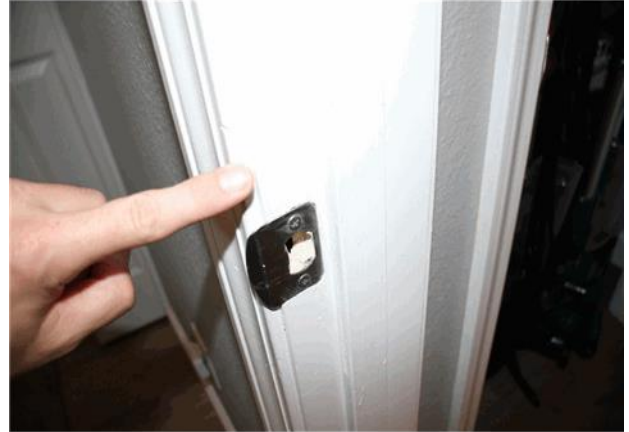
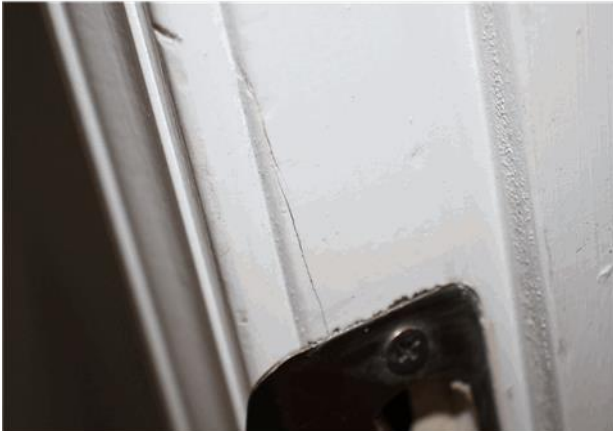
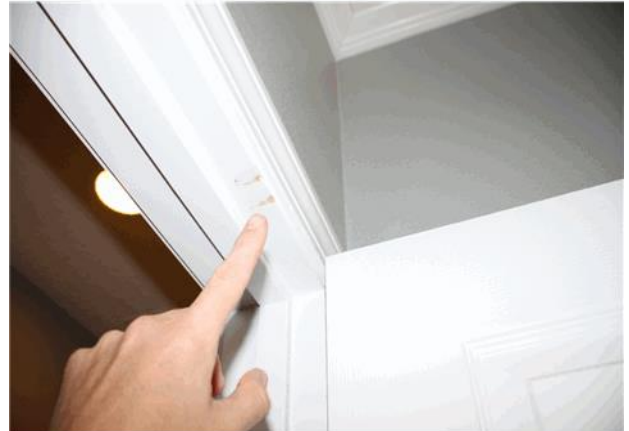
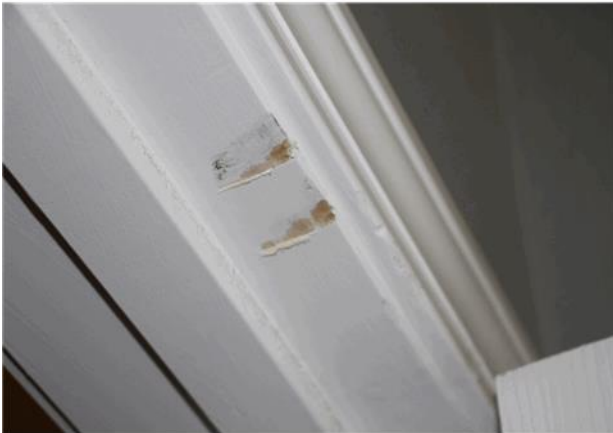
**58) Interior Door Conditions**

Minor damage observed at one or more doors and/or door frames in guest bedroom 1. Recommend review/repair by a licensed handyman.

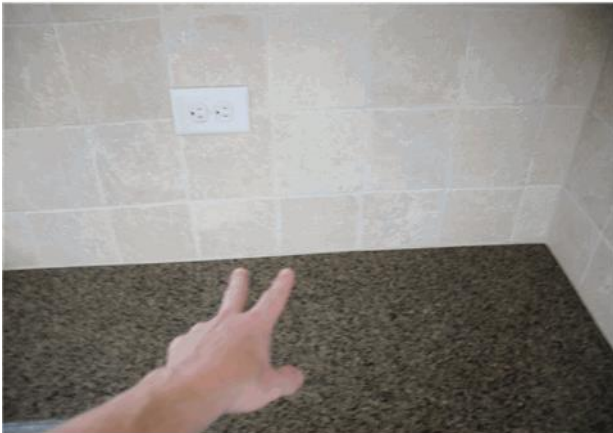
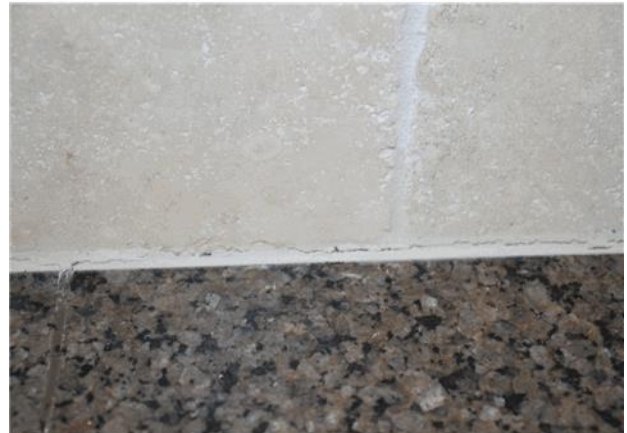
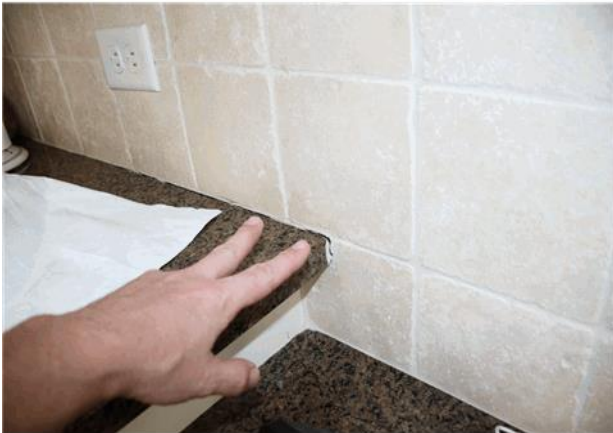
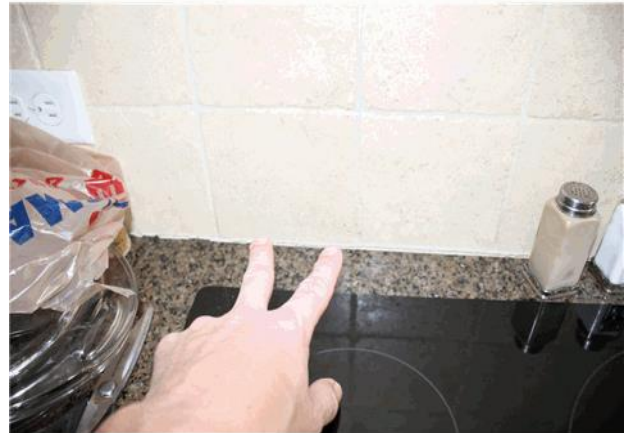
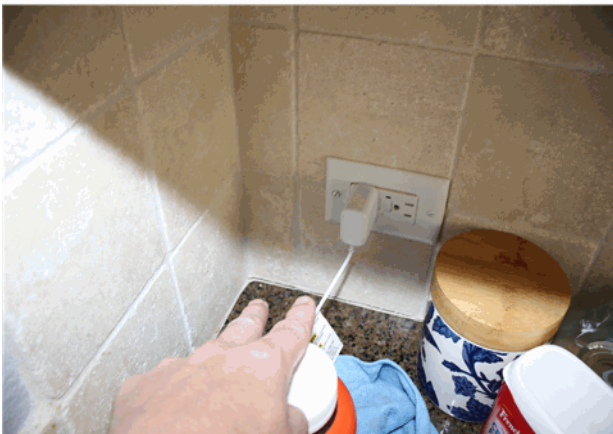
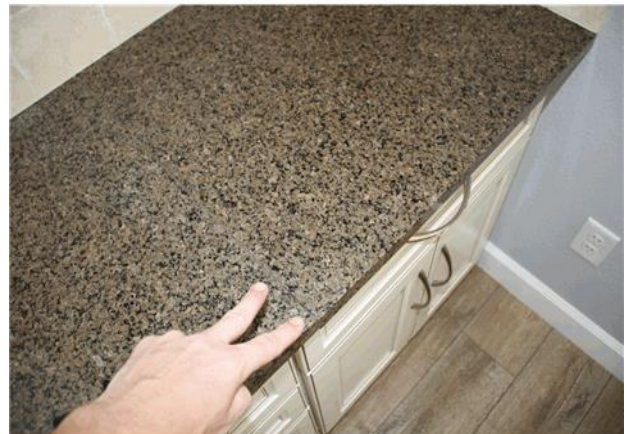
75) Counter Conditions RR Missing sealant and/or caulk and/or grout observed at kitchen counter.  
Recommend review/repair by a licensed handyman.

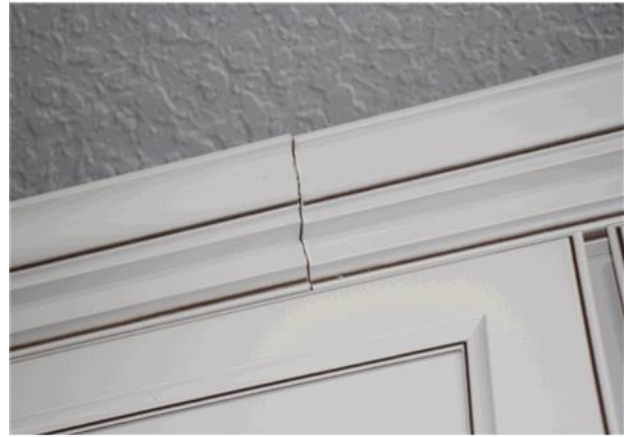
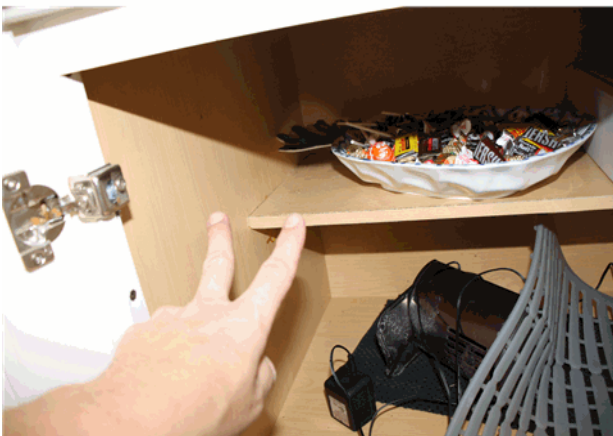
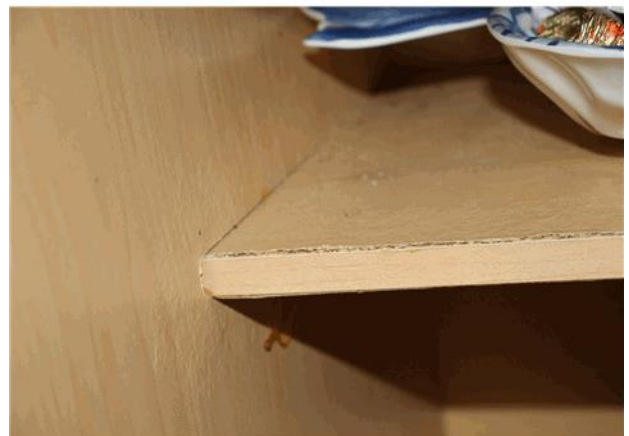
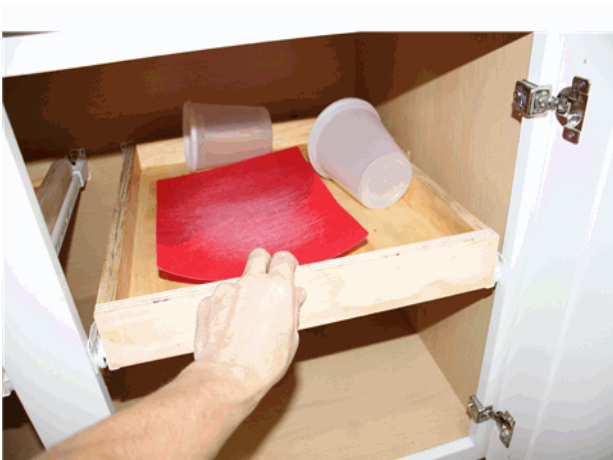
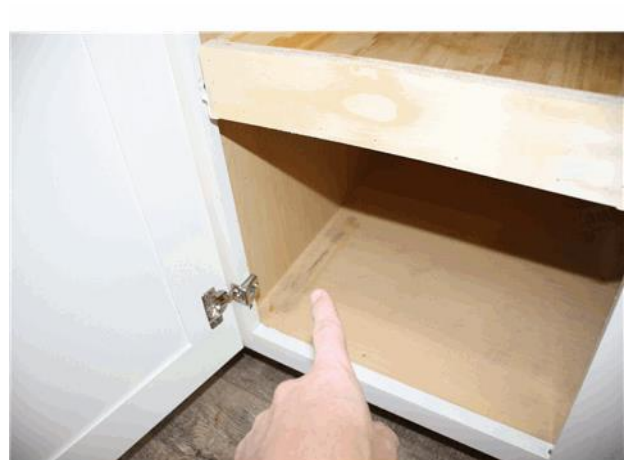
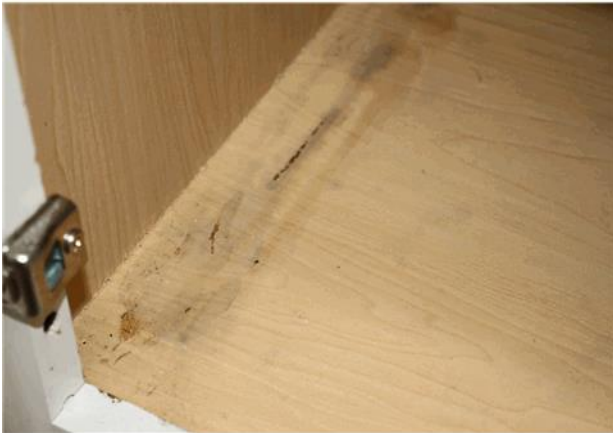
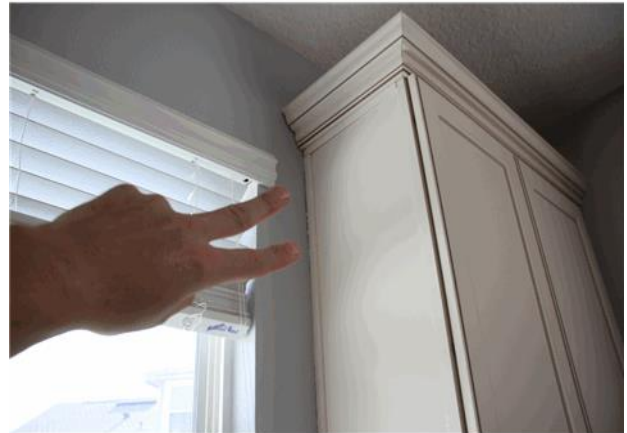
## 76) Cabinet Conditions

Missing sealant and/or caulking observed at one or more cabinets and/or trim in kitchen. One or more cabinets and/or drawers did not function properly in kitchen. The cabinets and/or drawers are aged in kitchen.

Wear and tear observed. Recommend review/repair by a licensed handyman.

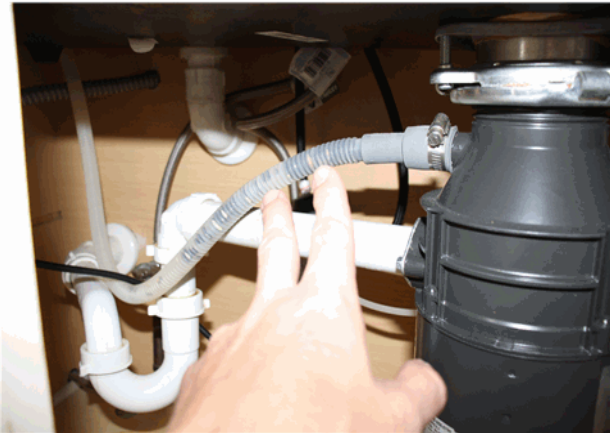
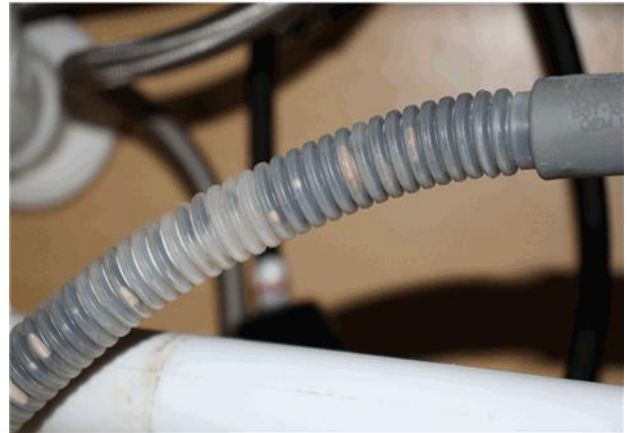
**78) Garbage Disposal  
Condition**

"Debris" observed in garbage disposal drain line. Recommend review/repair by licensed plumber.

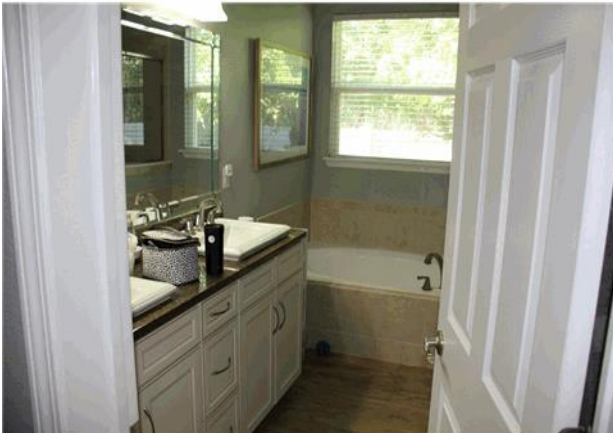
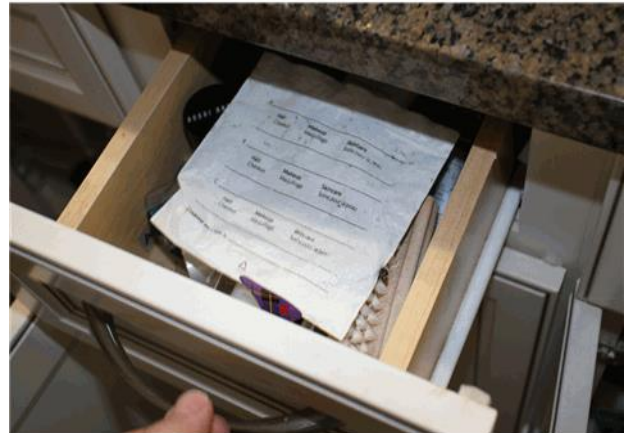
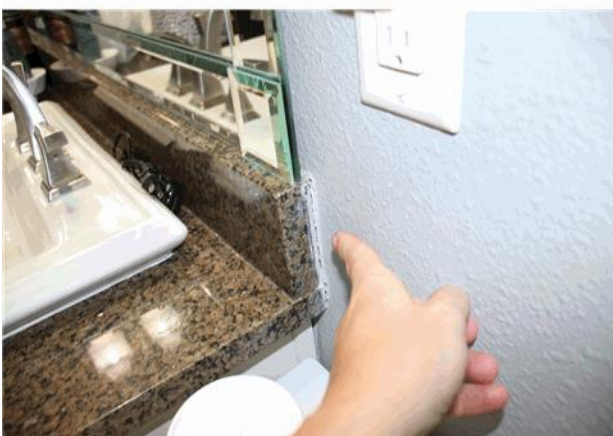
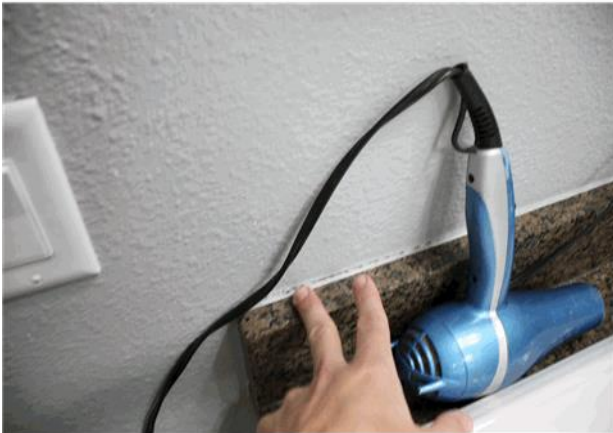
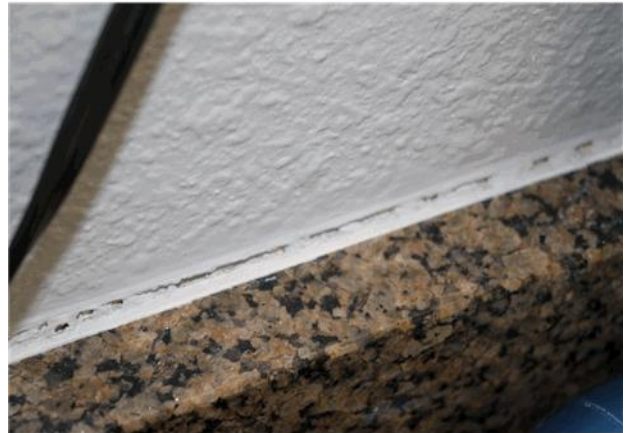
**91) Counter - Cabinet Conditions**

One or more cabinets and/or drawers require adjustment and/or repair in master bath. Missing sealant and/or caulking and/or grout observed at counter in master bath. Recommend repair by a licensed handyman.

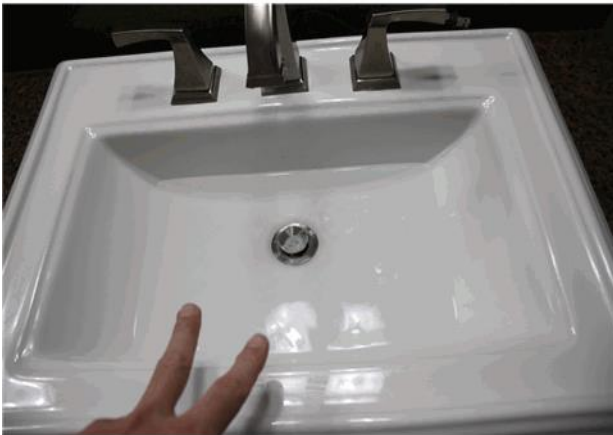
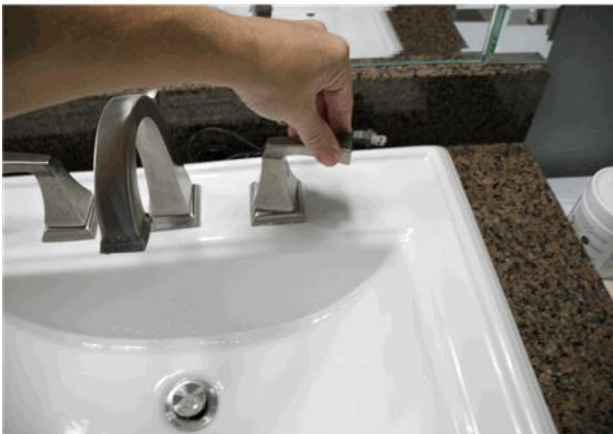
## 92) Sink Conditions

One or more sinks drained slowly in master bath. One or more faucet handles were difficult to operate in master bath. Recommend review/repair by licensed plumber.
