# Inspection Report

Provided by: High Tide Inspections LLC

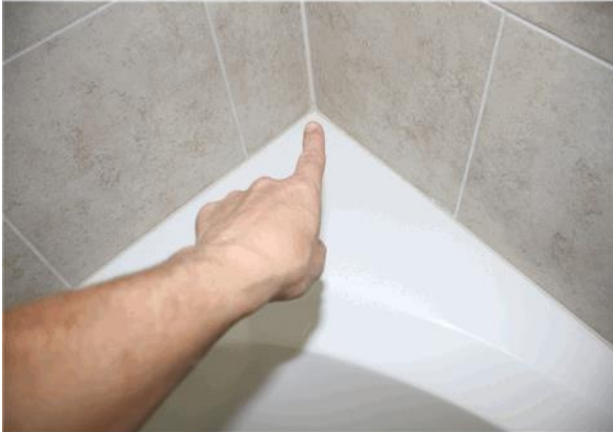
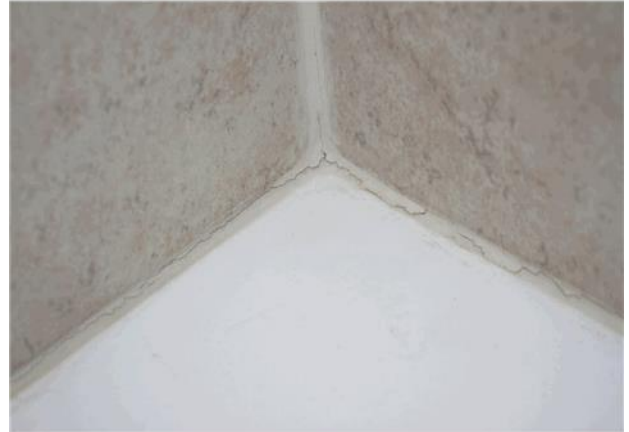
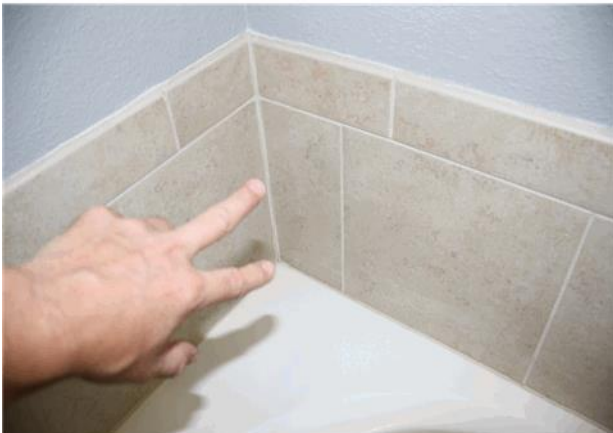
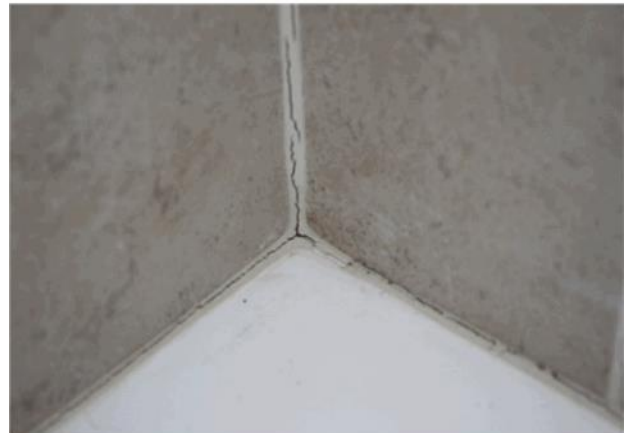
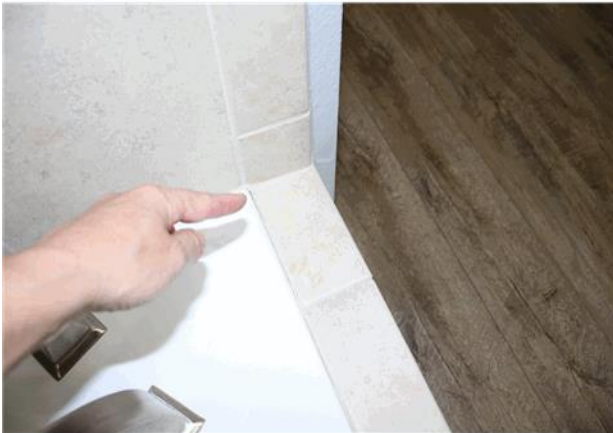
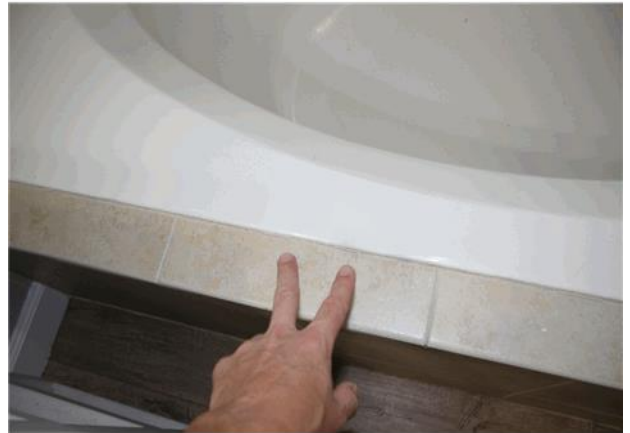
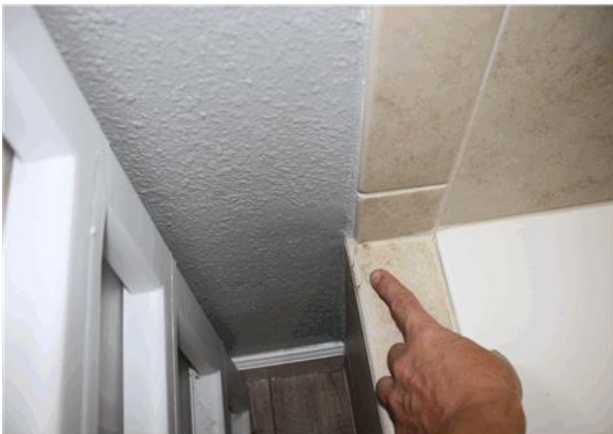
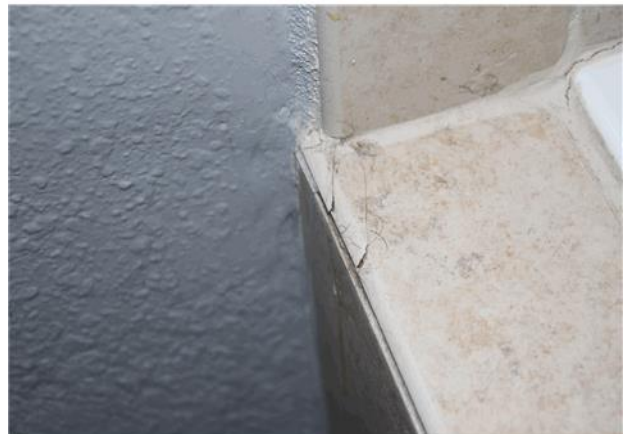
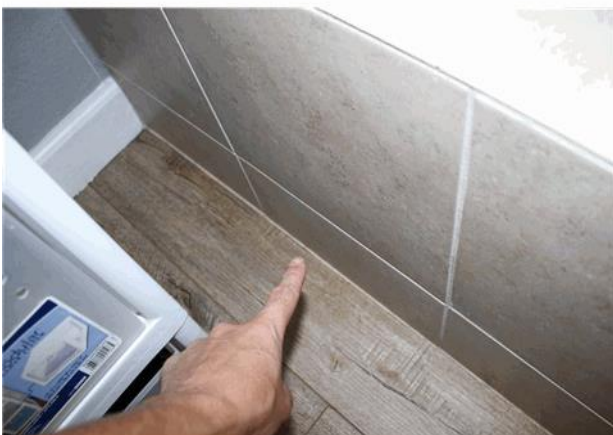
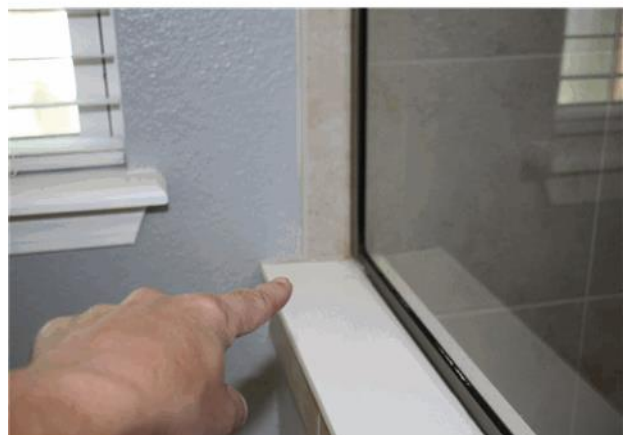
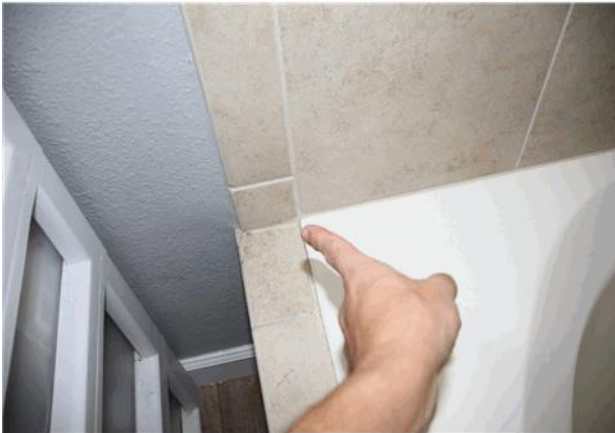
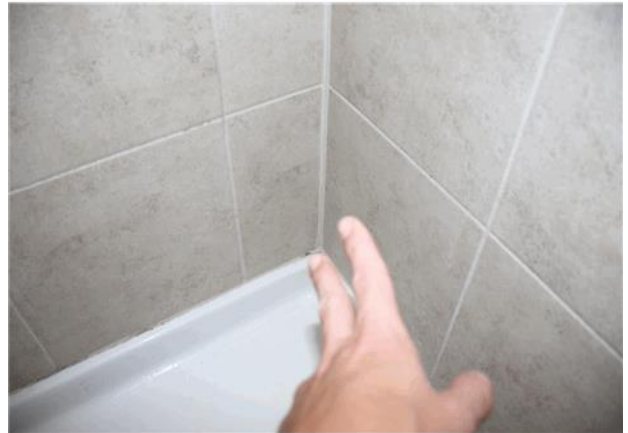
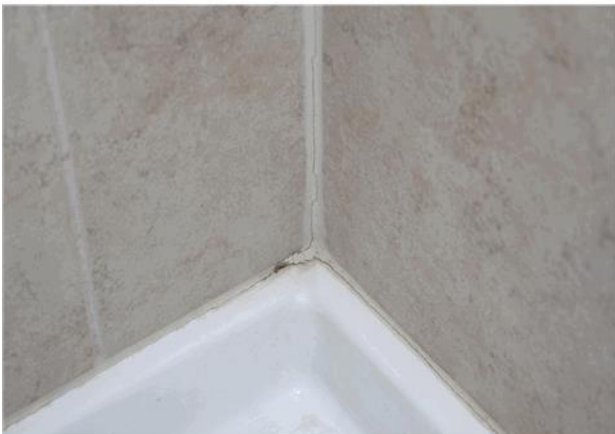
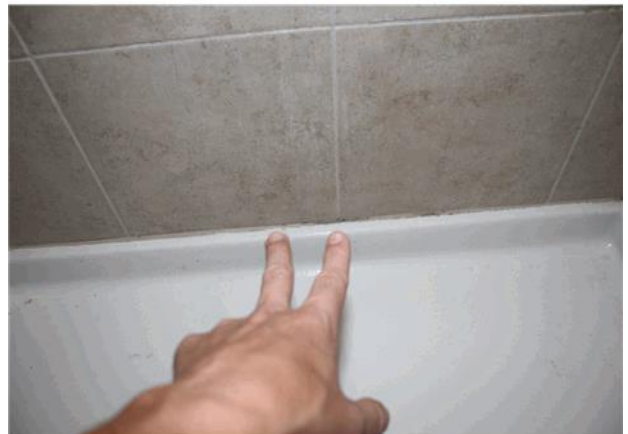
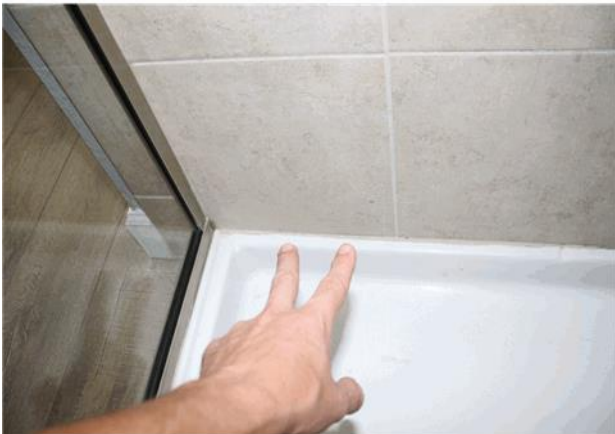
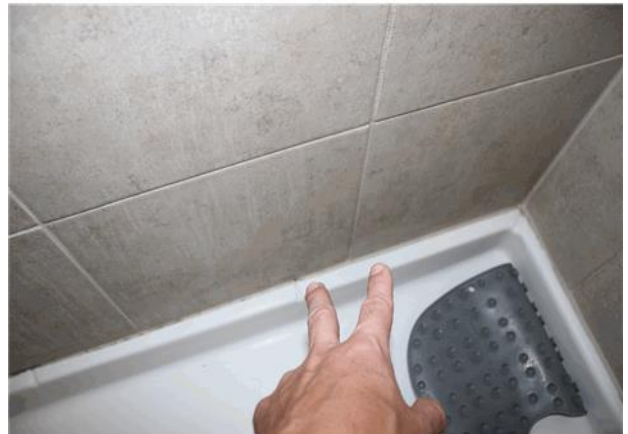
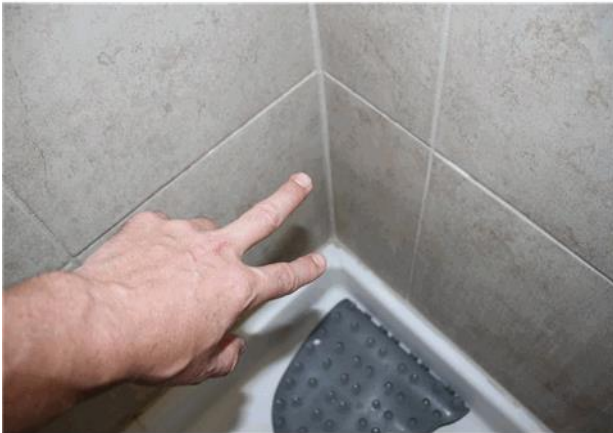
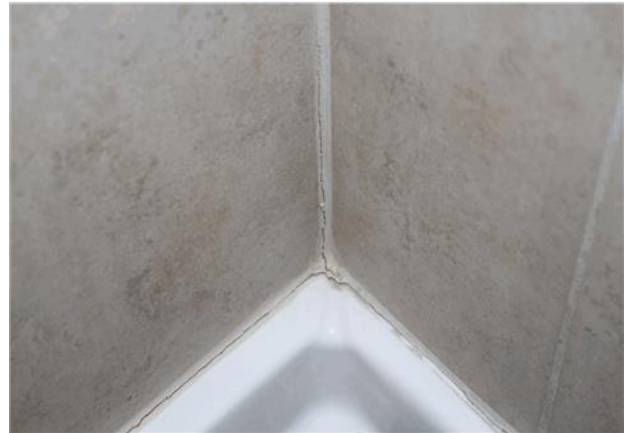
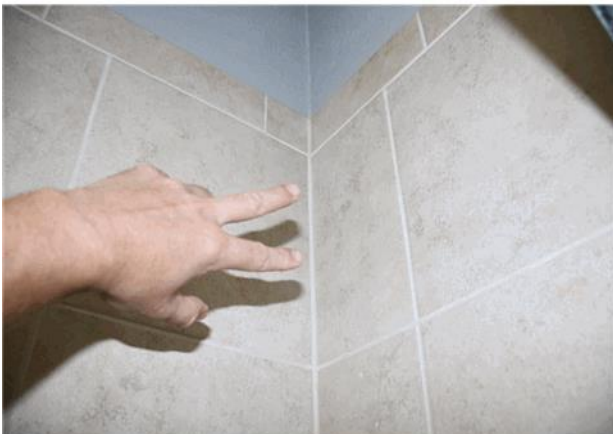
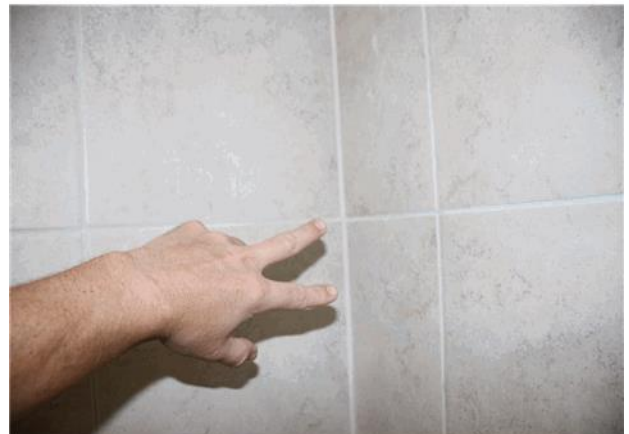
#### 93) Shower - Tub Conditions

Cracked and/or missing grout observed at shower and/or tub in master bath. Damage to tile observed. Recommend review/repair by a licensed handyman.

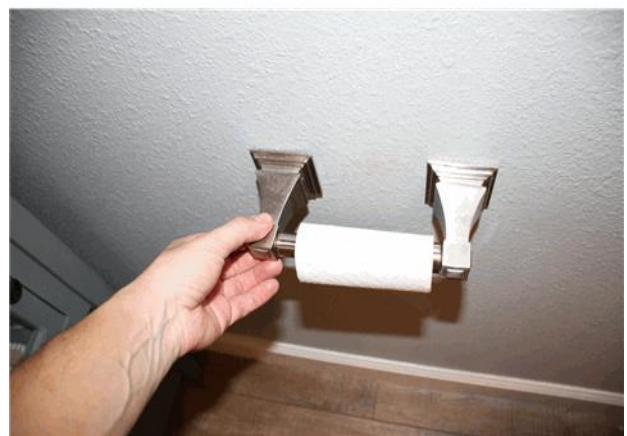
The toilet paper "holder" was loose in guest bath 1. Recommend review/repair by a licensed handyman.

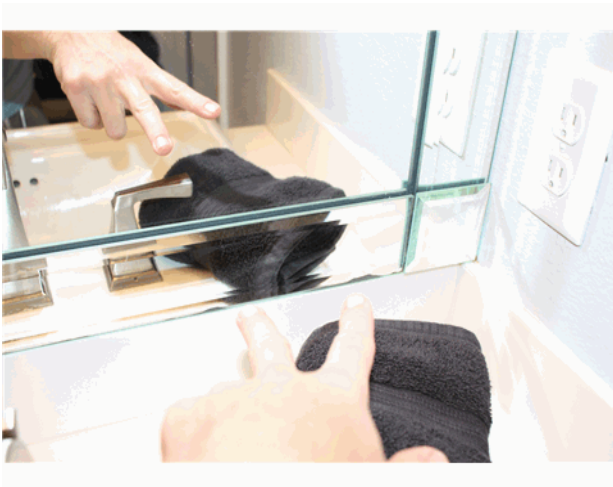
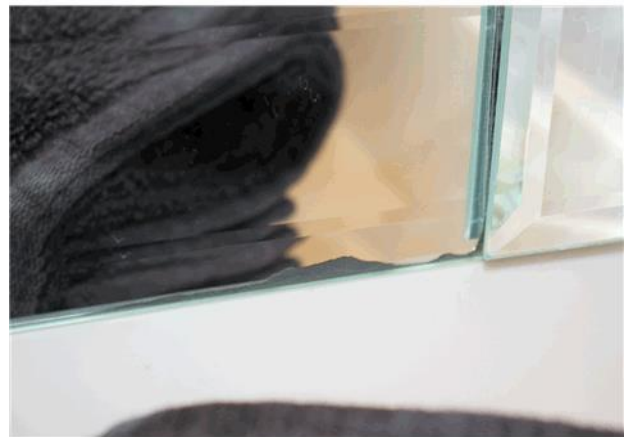
**113) Mirror Conditions** RR "Aging" observed at mirror in guest bath 2. Repair as needed.

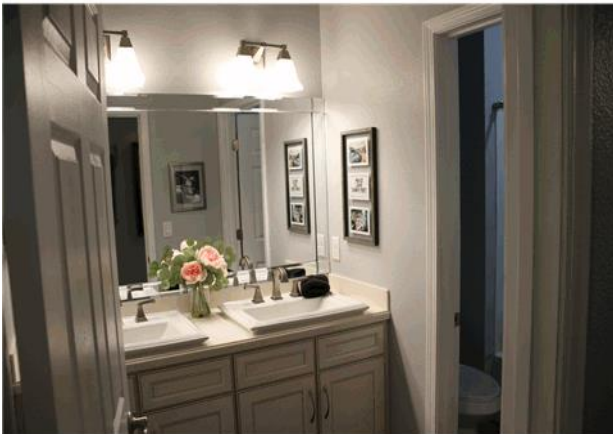
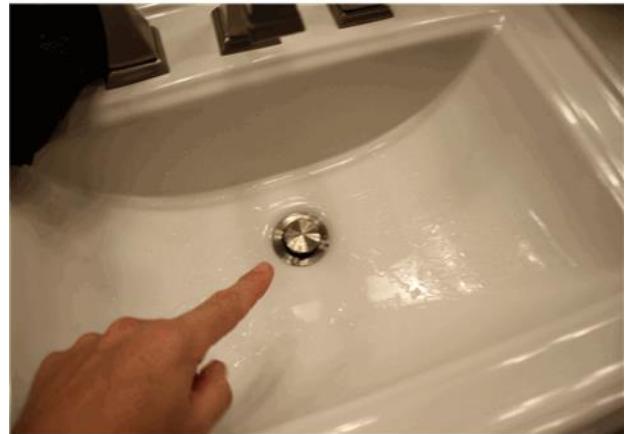
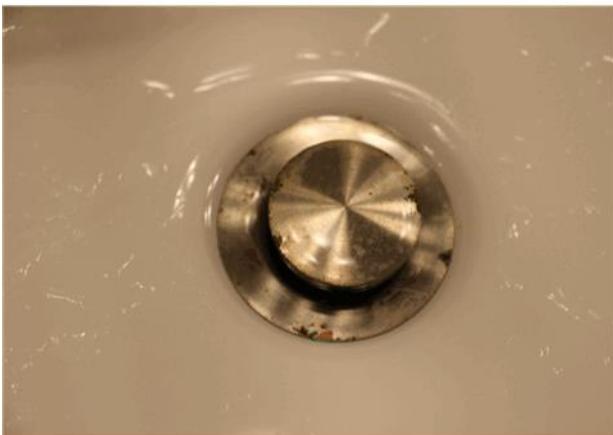
120) Sink Conditions

Minor corrosion observed at drain stopper in guest bath 2. Recommend review/repair by a licensed professional.

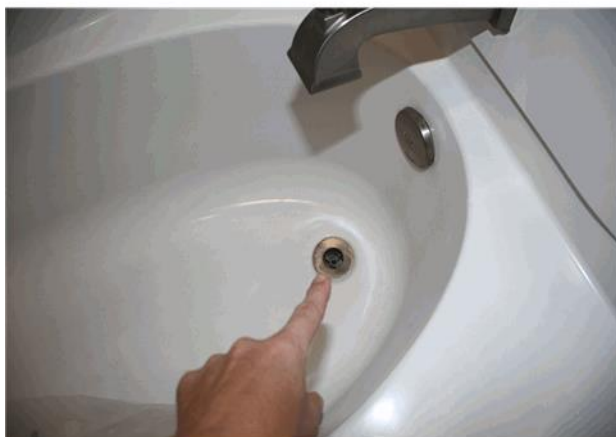
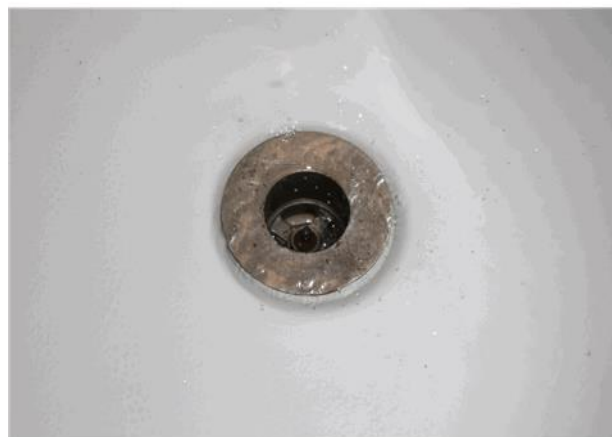
### 121) Shower - Tub Conditions

Minor corrosion at tub drain observed in guest bath 2. Missing "stopper" observed. Recommend review/repair by licensed plumber.

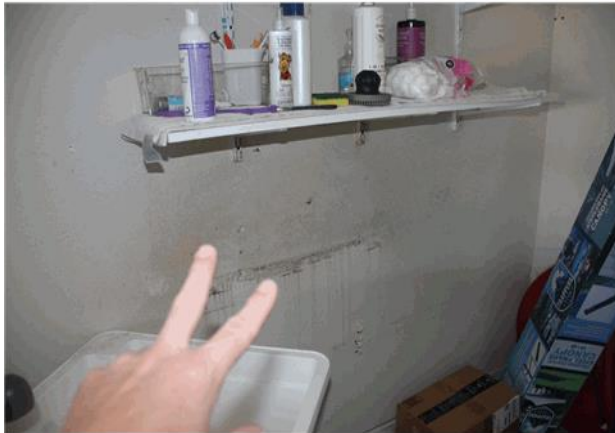
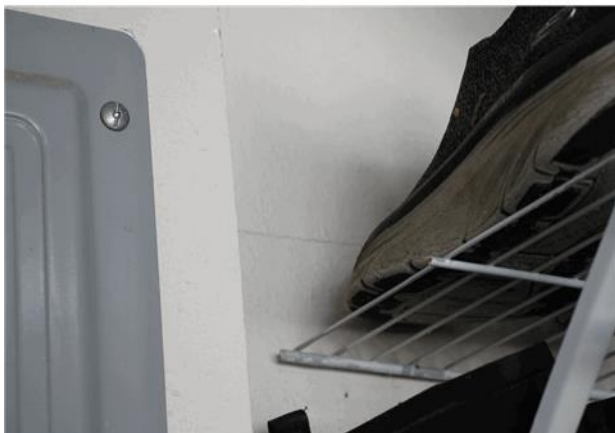
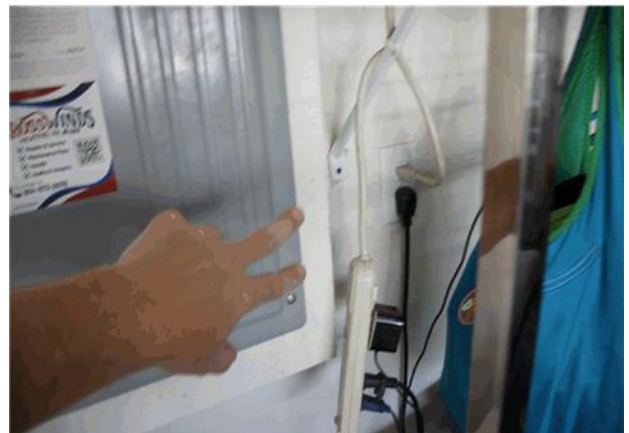
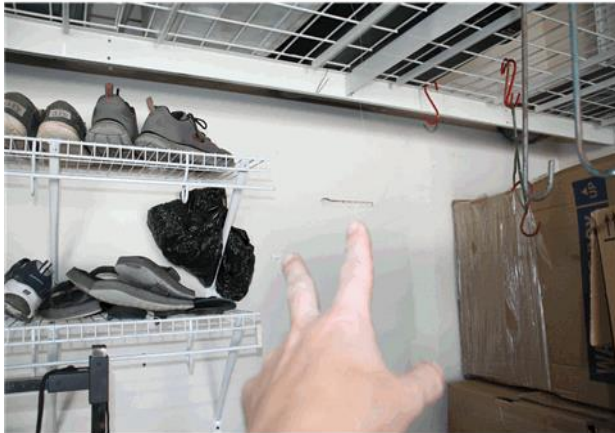
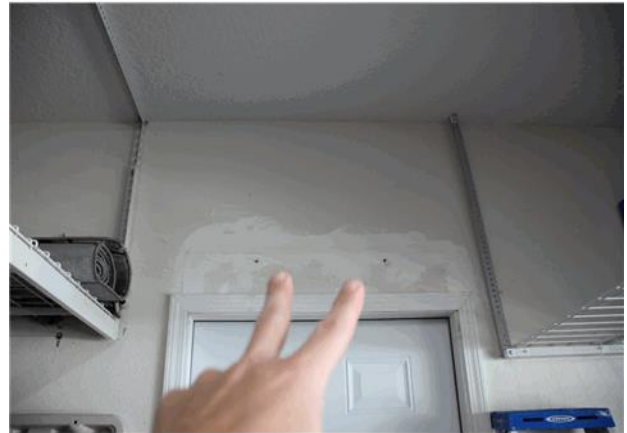
#### 123) Wall Conditions

Normal "wear and tear" observed at garage walls. Cracking and/or damage observed at one or more garage walls. Moisture stains (likely from condensation) observed at one or more garage walls. One or more repairs observed. Recommend review/repair by a licensed handyman.

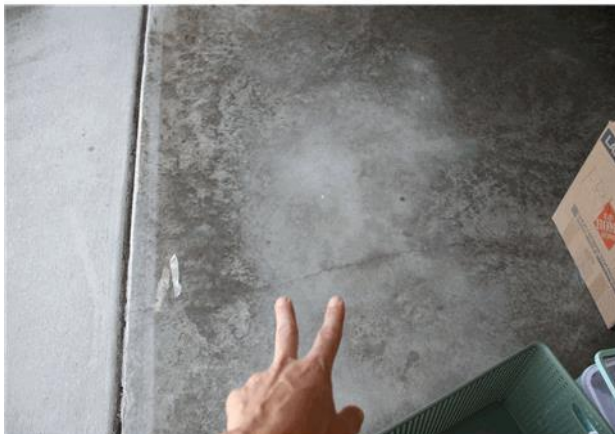
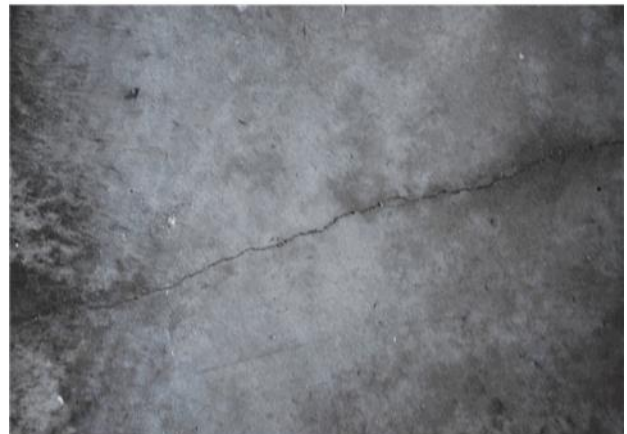
#### 125) Floor Conditions

Common cracks and settlement were observed at garage floor. Recommend review/repair by a licensed contractor.

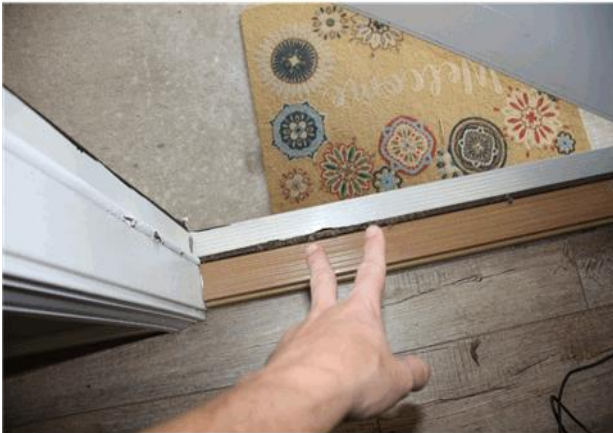
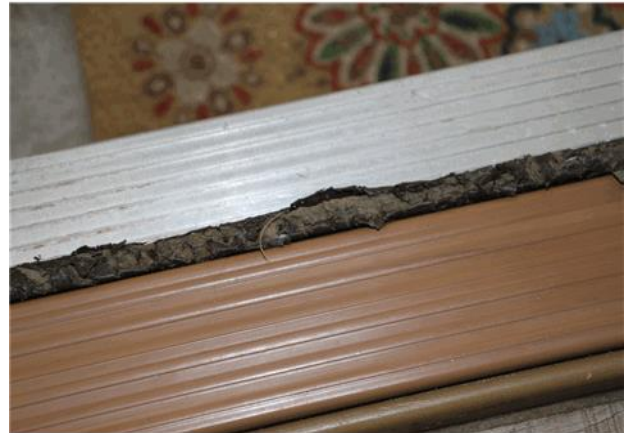
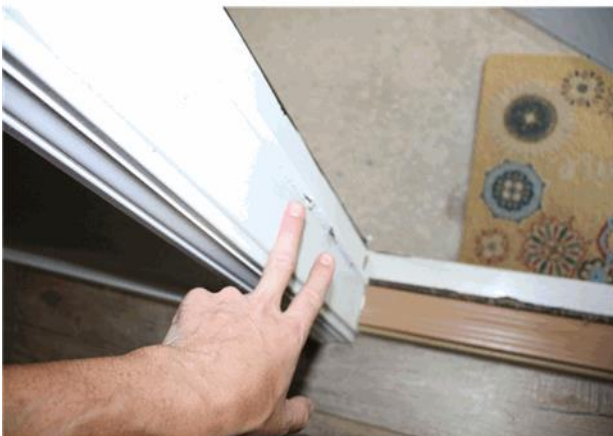
#### 126) Door Conditions

The weather seal was missing and/or damaged at one or more doors in garage. The hardware at one or more doors did not function properly in garage. Recommend review/repair by a licensed handyman.
